Ballyhale Flood Relief Scheme, Ballyhale, Co. Kilkenny

Environmental Constraints Report

Job Title: Ballyhale Flood Relief Scheme

Report Ref: 200055-DBFL-XX-XX-RP-0002

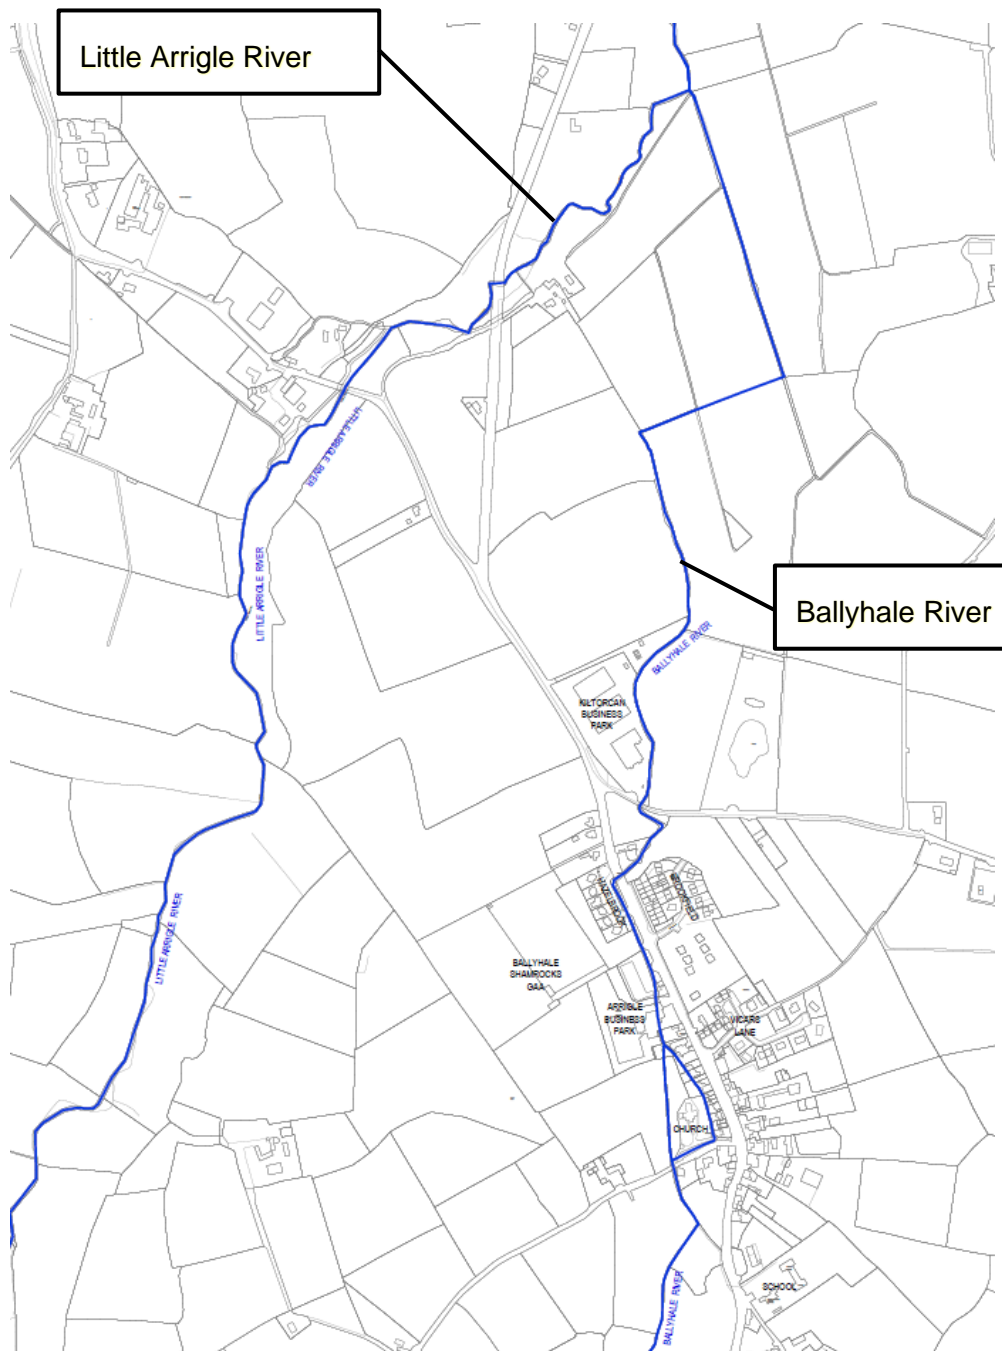
Ballyhale is within the catchment of the Little Arrigle River which is a tributary of the River Nore. The main channel of the Little Arrigle runs to the west of the village and a tributary of the Little Arrigle runs through the village. This tributary is also known locally as the Little Arrigle however will be termed the Ballyhale River for the purposes of this assessment (this is also referred to in EPA mapping as Knockwilliam Stream). The Ballyhale River enters the village near the church and splits into two channels either side of the church. Several culverts/bridges are present on the watercourse along its route through the village.

Figure 2-1 – Local Watercourses

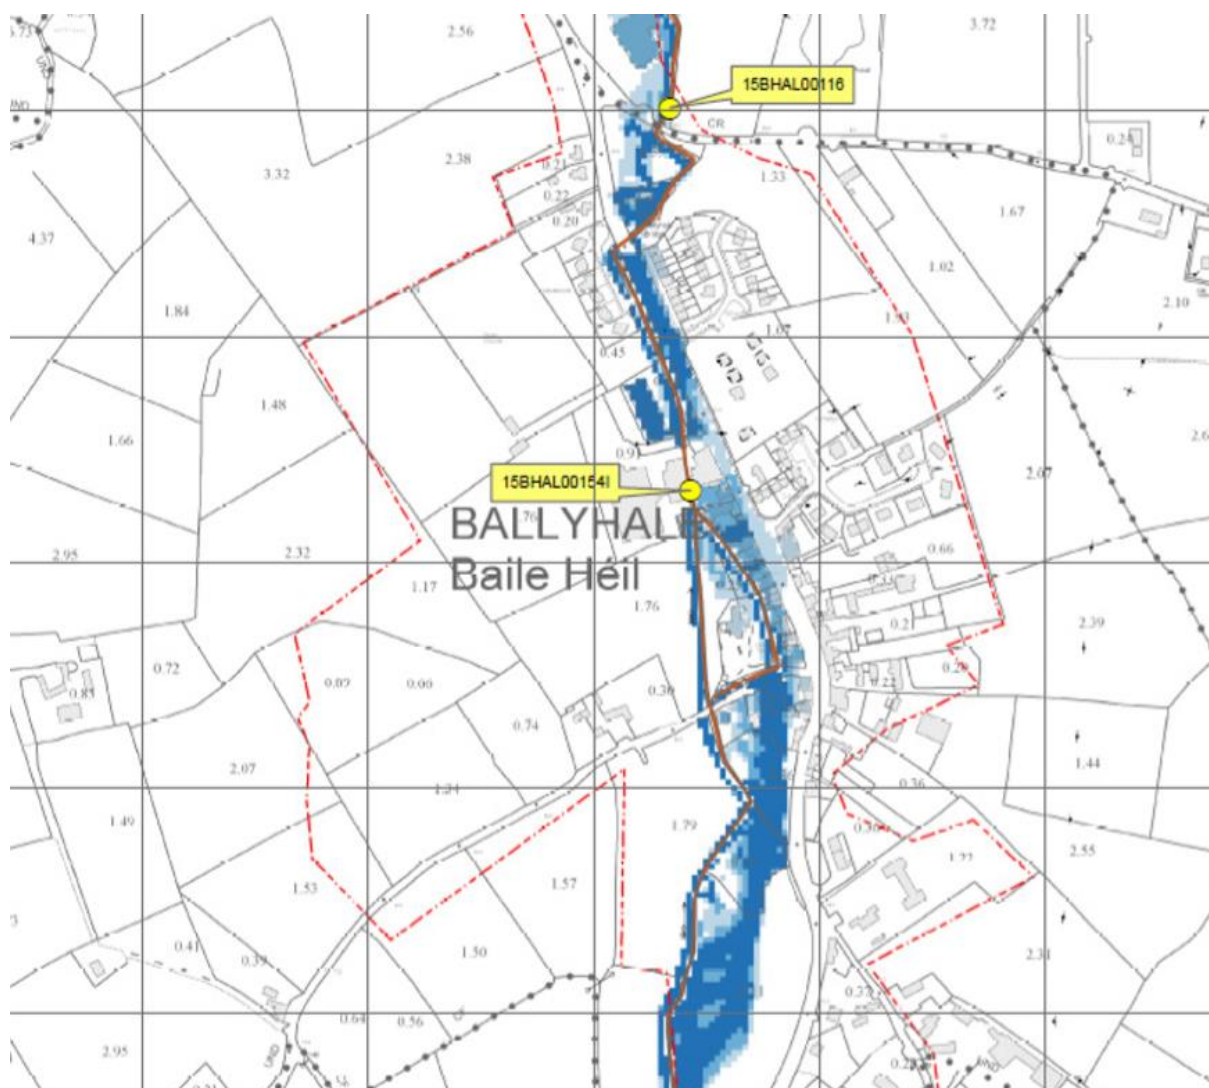
The South Eastern CFRAM carried out a study of flooding in Ballyhale which included hydraulic modelling. The study predicted that out of bank overland flooding occurs upstream of the village on the eastern bank of the Ballyhale River. These floodwaters flow overland across agricultural lands and into the village. Flooding is also affected by a number of undersized culvert/bridge structures on the watercourse through the village. The study estimated that 25 properties in Ballyhale are at risk of flooding for the current day 1% Annual Exceedance Probability (AEP) event. An extract from the CFRAM flood mapping is presented in Figure 2-2.

Figure 2-2: Fluvial Flood Extents 1% AEP
(Source - CFRAM O15BAE_EXFCD_F0_01)

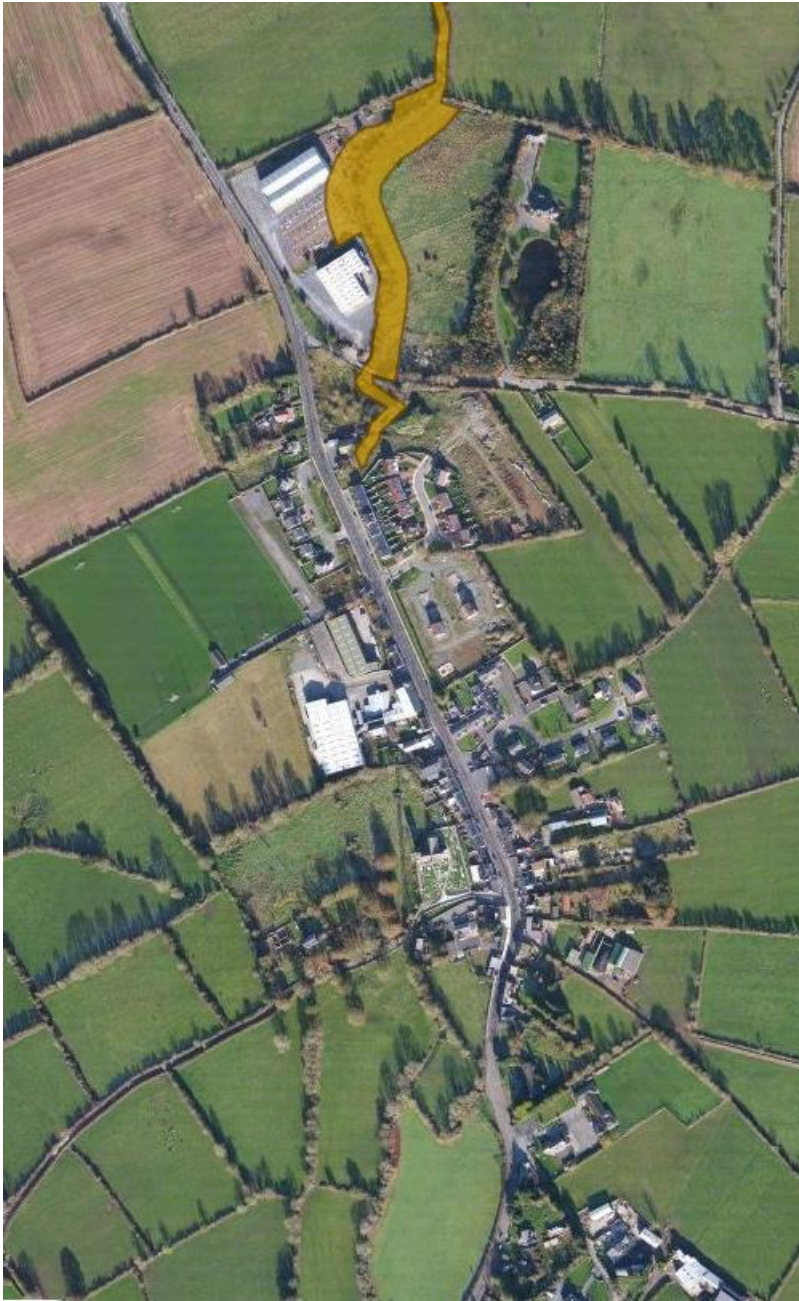
Figure 3.2: River Barrow and River Nore SAC Boundary

The River Barrow and River Nore SAC designated area is located to the north of the constraints area as shown in Figure 1.2. This SAC is designated for numerous qualifying interests. The potential disturbance on protected species due to noise and increased dust concentrations would not be considered to be potentially significant, given the nature and scale of the proposed project. With regards to potential air pollutant and dust emissions from the proposed project, it is likely that the main emission sources would comprise of vehicular emissions and windblown dusts which may be significant at certain locations within the constraints area.

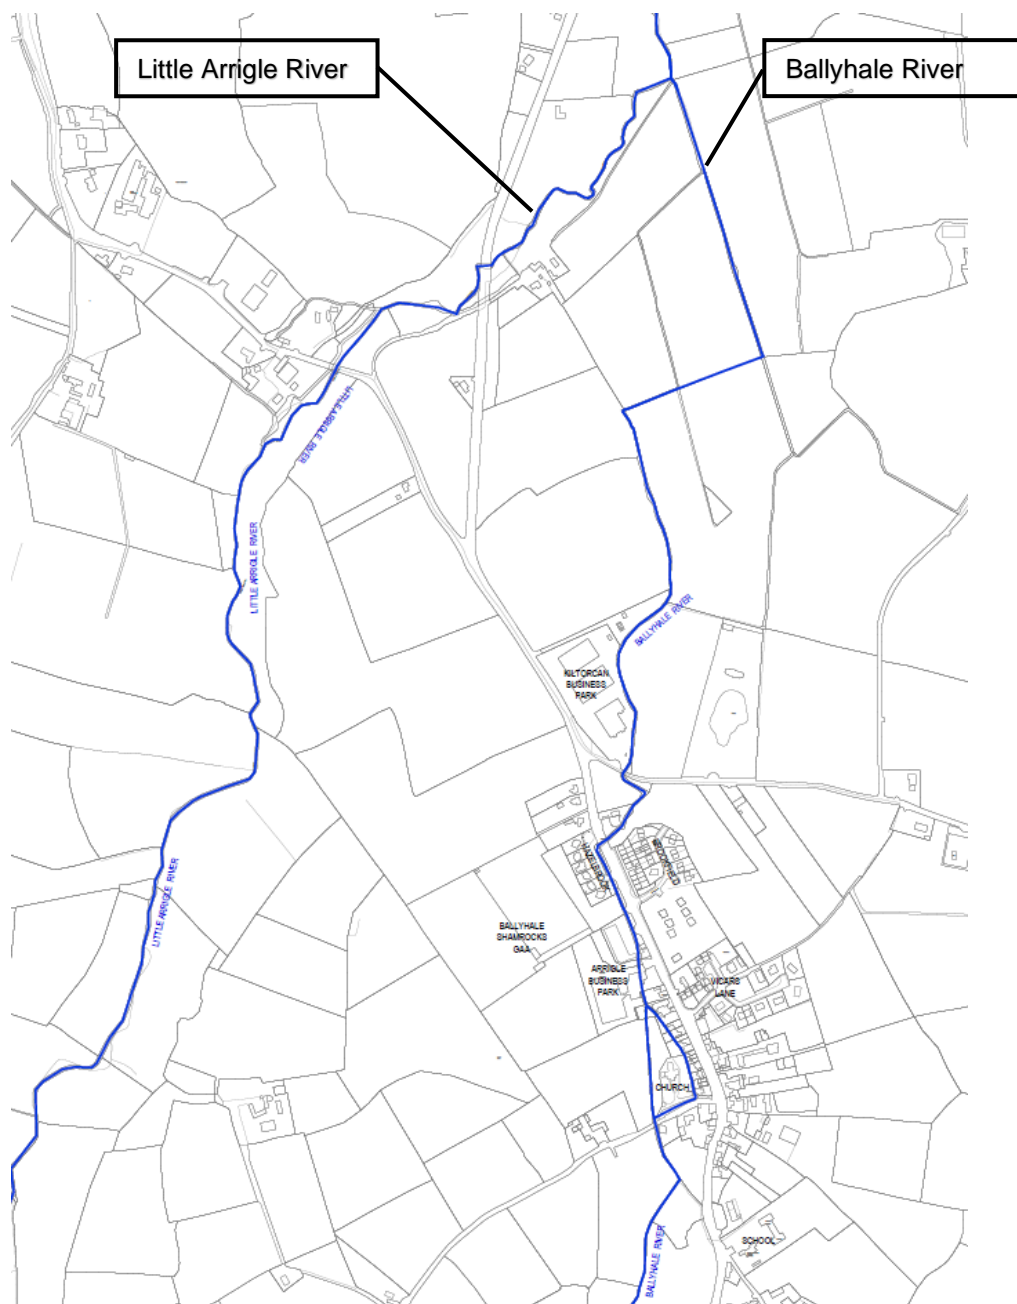
Ballyhale is within the catchment of the Little Arrigle River which is a tributary of the River Nore. The main channel of the Little Arrigle runs to the west of the village and a tributary of the Little Arrigle runs through the village. This tributary is also known locally as the Little Arrigle however will be termed the Ballyhale River for the purposes of this assessment (this watercourse is also referred to in EPA mapping as Knockwilliam Stream). The Ballyhale River enters the village near the church and splits into two channels either side of the church. Several culverts/bridges are present on the watercourse along its route through the village.

Figure 4.2: Local Watercourses

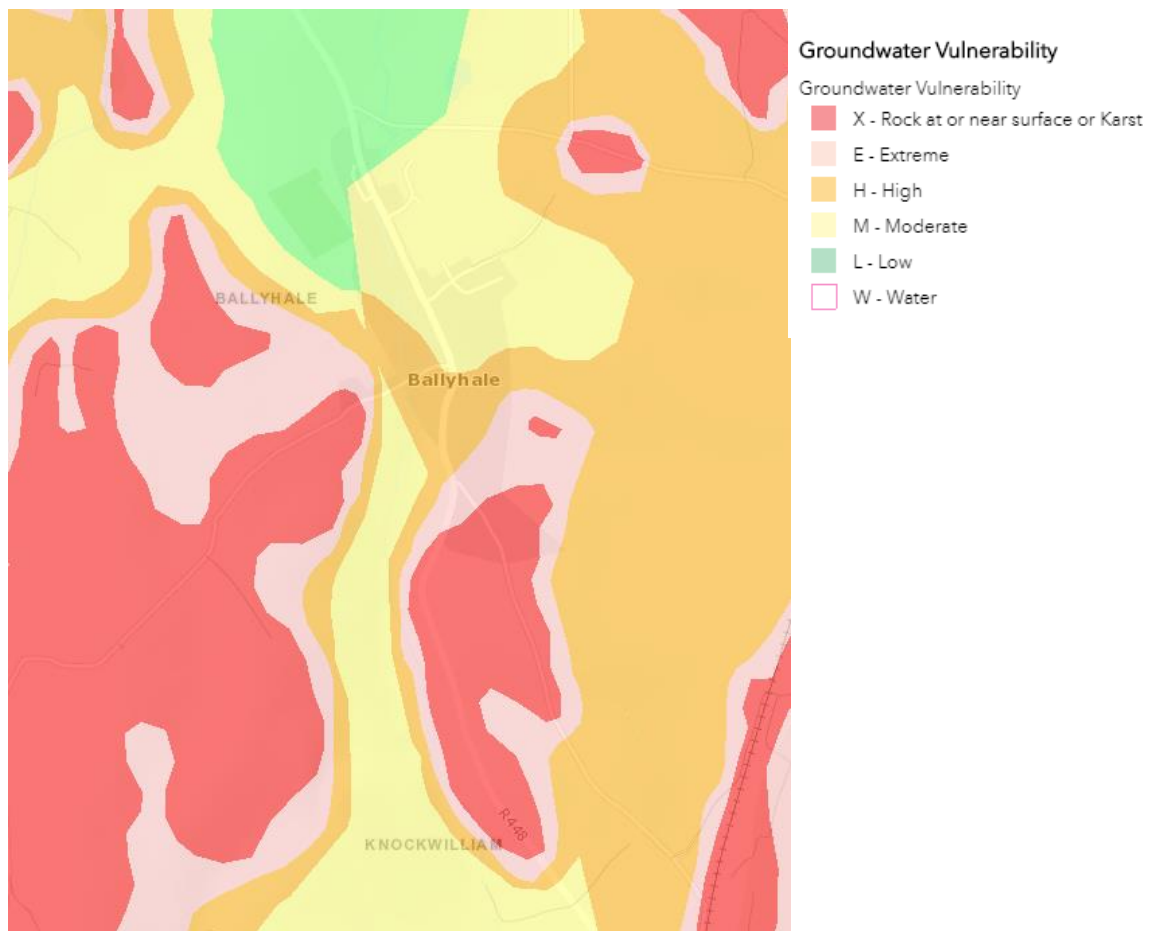
Groundwater Vulnerability is a term used to represent the intrinsic geological and hydrogeological characteristics that determine the ease with which groundwater may be contaminated by human activities. Groundwater vulnerability is classed from moderate to extreme across the southern half of the project extents due to the shallow depth to bedrock and relatively permeable soils. Areas of highest vulnerability correspond to areas of near surface bedrock and thin soil depths. It is noted that the aquifer vulnerability classification does not consider the nature of the underlying ‘receiving’ aquifer with respect to resource value or significance of pollution occurring and is only a reflection on the protection afforded to the aquifer by overlying deposits.

Figure 4.4: Groundwater Vulnerability

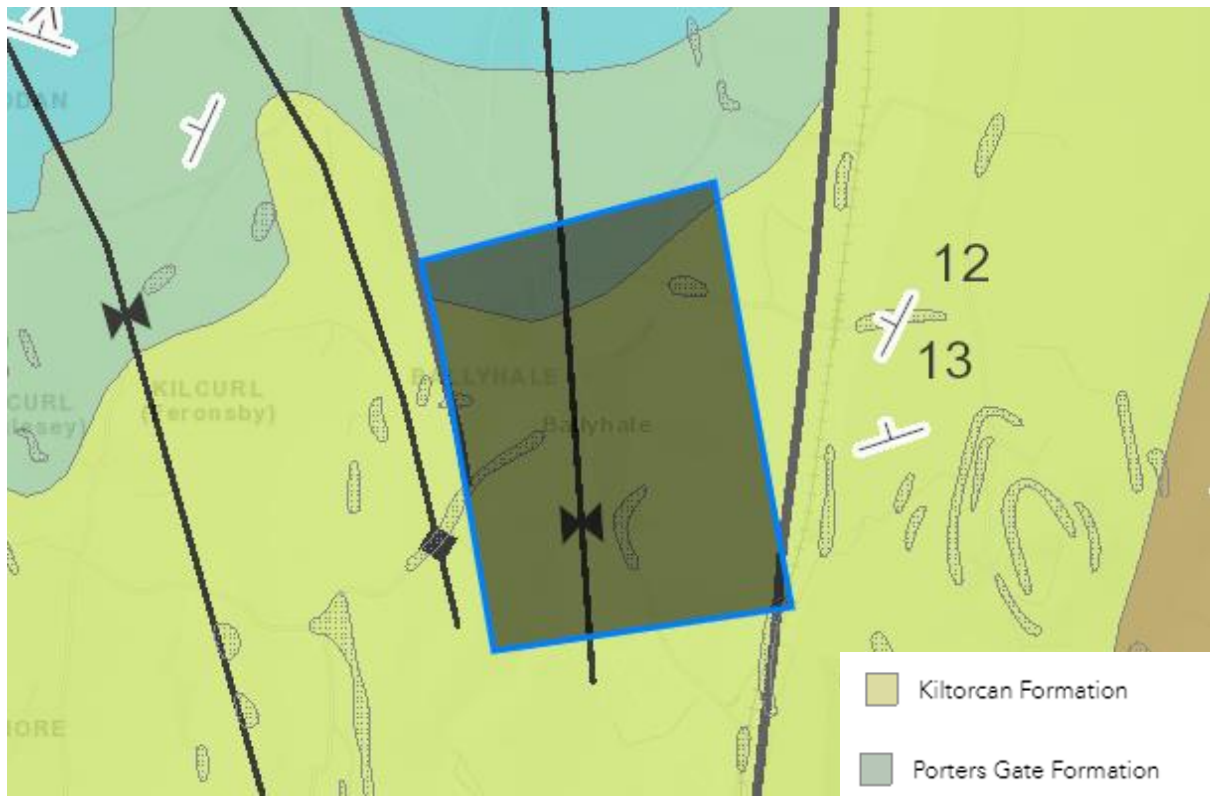
A number of bedrock outcrops in the vicinity of the site were noted on geological mapping and some bedrock was visible within stream channels during site walkovers.

Figure 5-2 Bedrock Geology

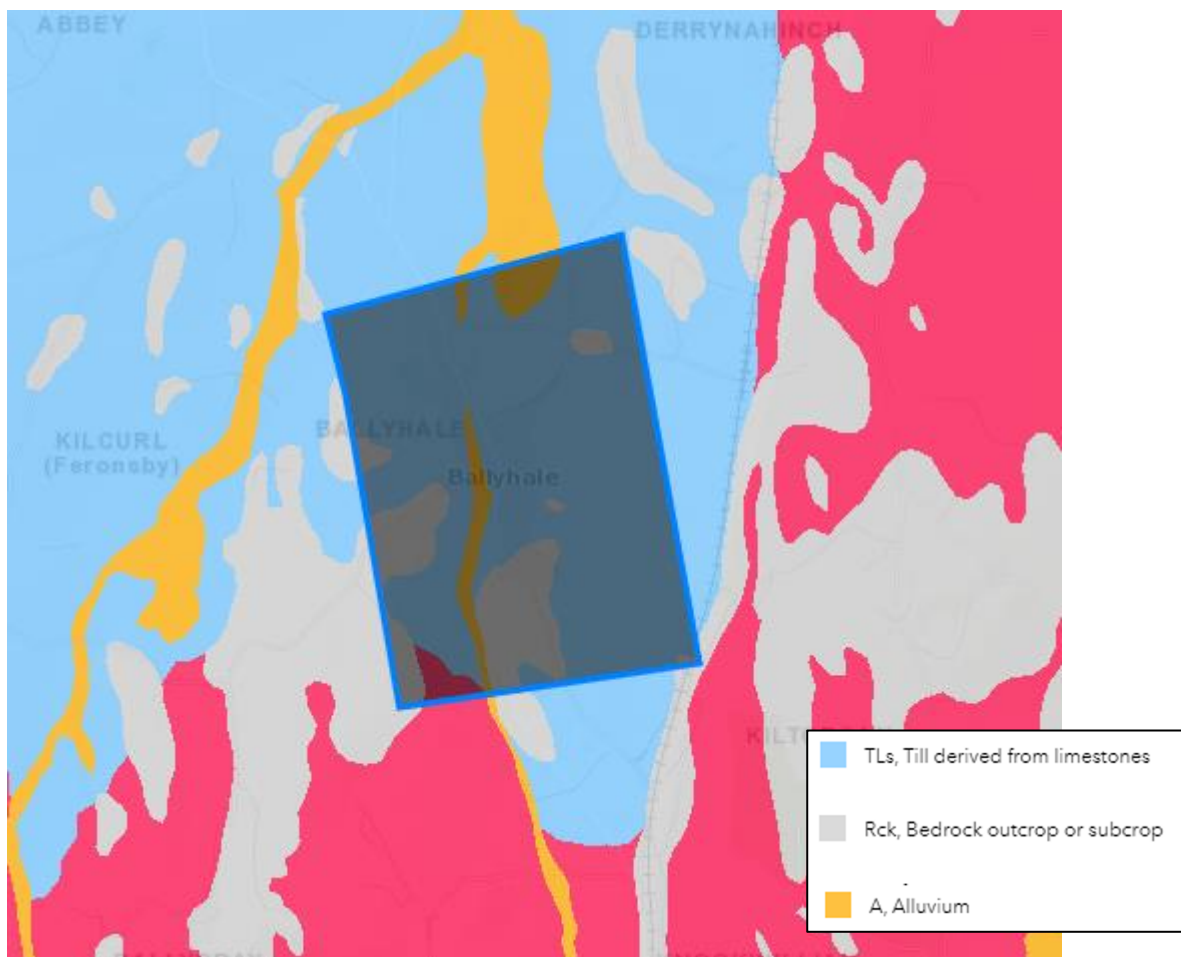
Generally site inspection showed good correlation with mapped data

Figure 5-3: Quaternary Sediments

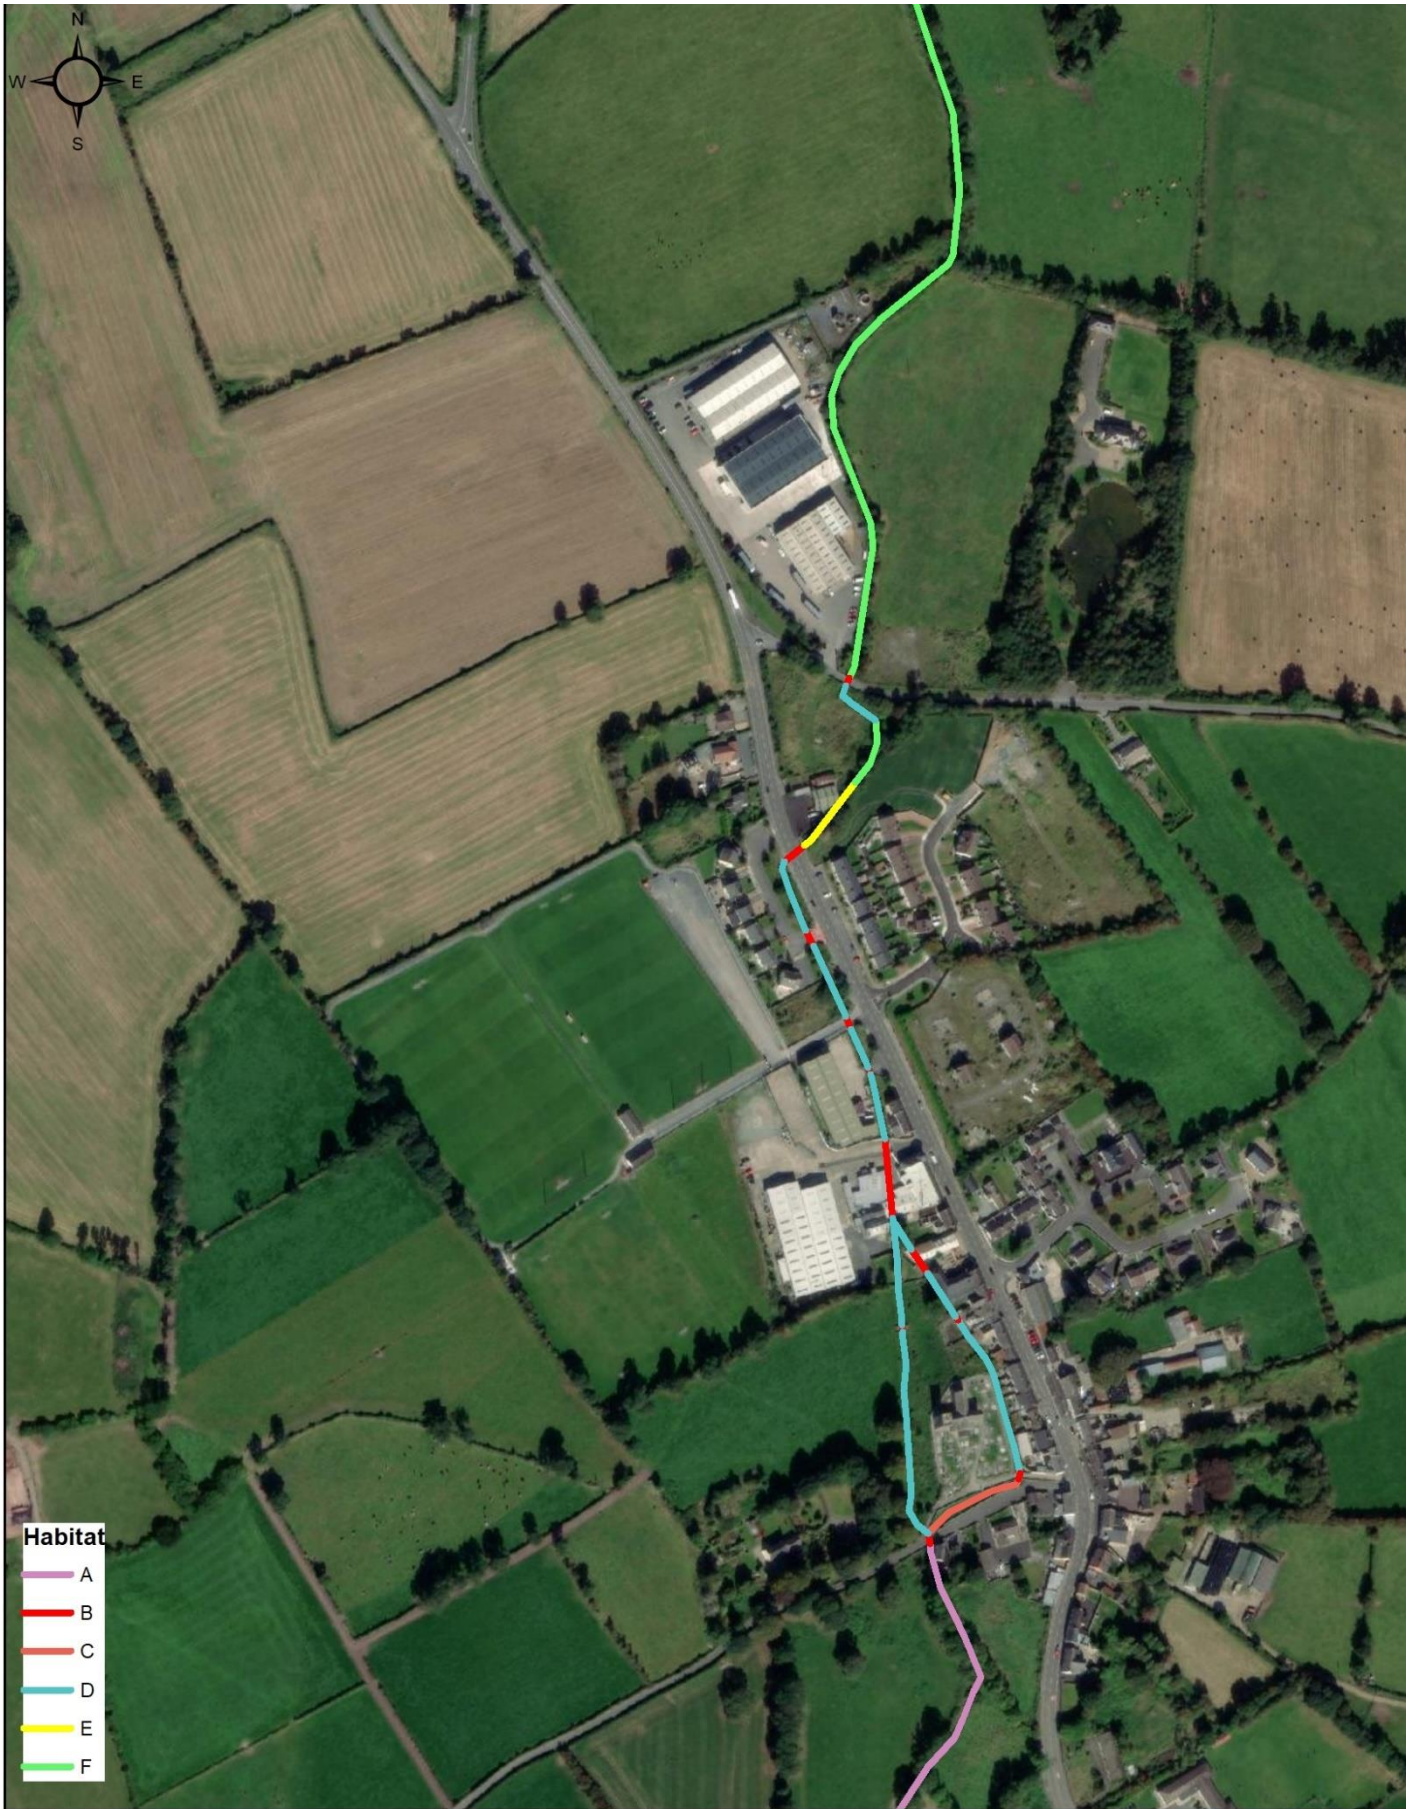
During the survey September 2020 the section of Ballyhale Stream was walked and divided into sections based on the habitat type and species present (Figure 2). No quantitative samples were taken, nor were any samples returned to the laboratory for analysis. The results from the survey are presented for each habitat type (annotated A to F) present in the 1.5km-long section of stream that was surveyed.

Figure 2: Stream habitat typologies.

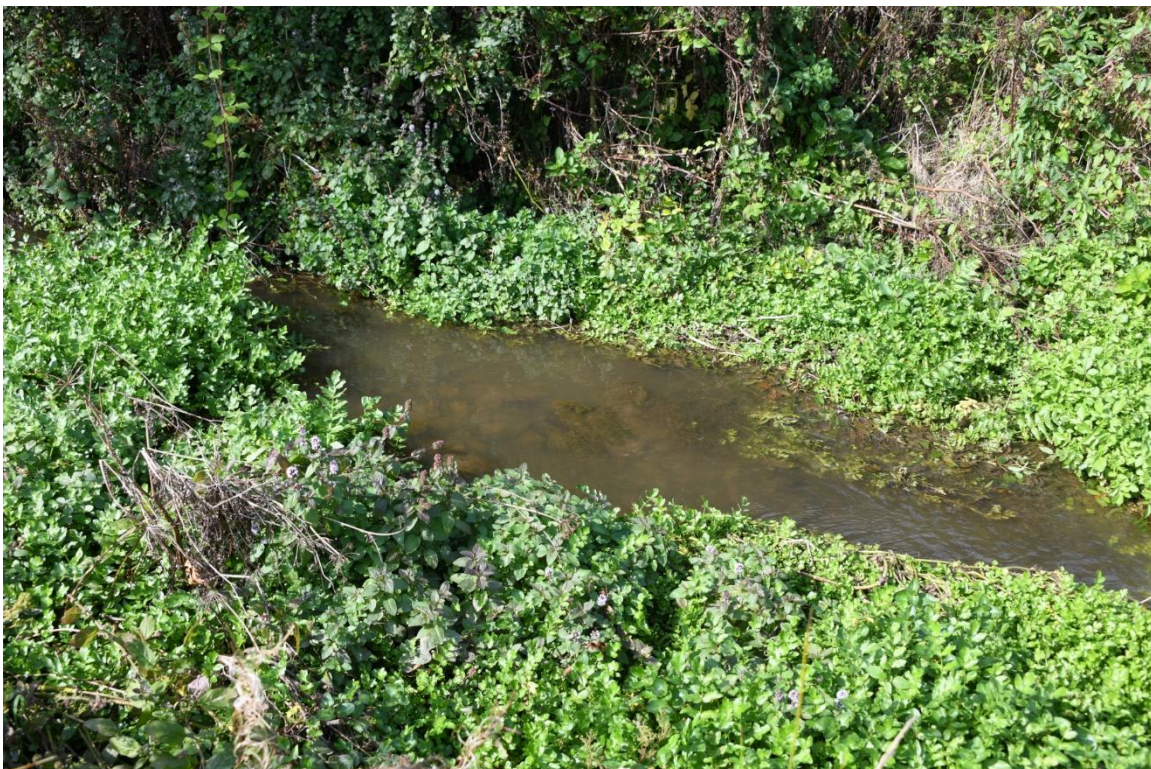
Plate 1. Section A

The channel of the stream at this location was relatively slow and sluggish and tunnelled beneath a mixture of hawthorn (*Crataegus monogyna*), ash (*Fraxinus excelsior*), blackthorn (*Prunus spinosa*) and gorse (*Ulex europaeus*). The frequent aquatic plants in this section were dense mats of watercress (*Nasturtium officinale*), water dropwort (*Oenanthe crocata*) and brooklime (*Veronica beccabunga*). An examination of the deep silt and mud deposits revealed no macroinvertebrate fauna. No fish were observed in this section. Sewage fungus was noted on the rocks.

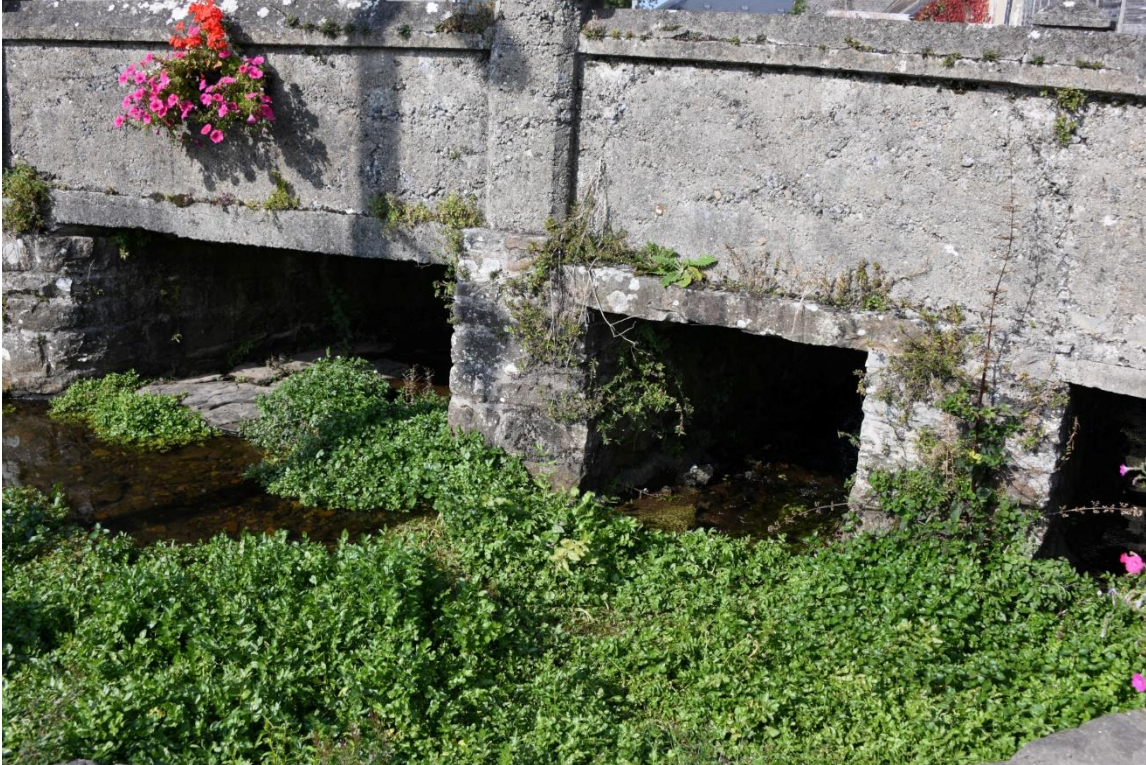
Plate 2. Bridge located at the downstream end of Section C

Numerous sections of the stream are bridged and culverted through the town. These include several level changes within the watercourse would obstruct migrating and non migrating fish within the watercourse. These would be particularly important within spawning season and during spells of hot weather. The obstruction in in Plate 3 would obstruct the movement of salmonids and other migratory fish species within the watercourse.

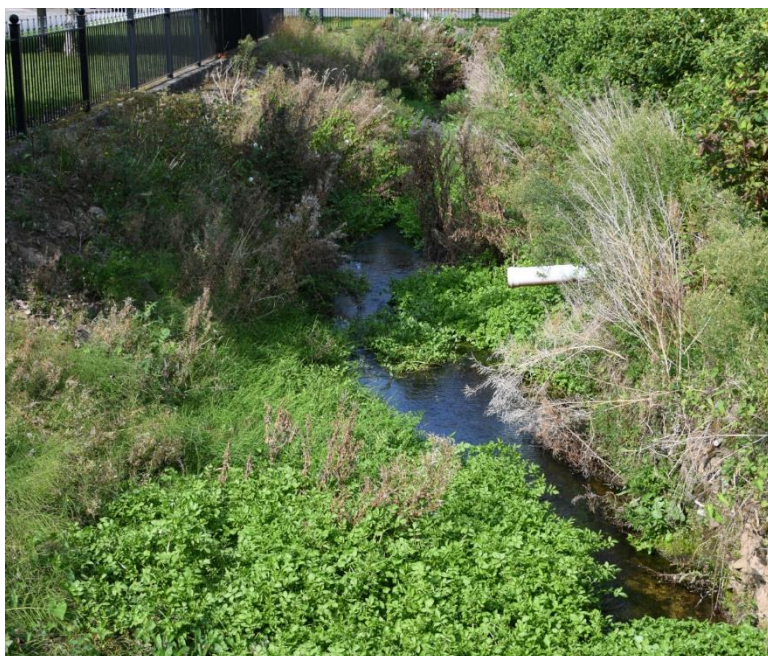
Much of the open water sections within the village were similar in nature. Throughout the village there is very little tree cover and there is dense instream vegetation to either side of the main stream channel. Very localised and small shoals of three-spined Stickleback (*Gasterosteus aculeatus*) were observed in the vicinity of the instream vegetation, but no salmonids were observed. Plant species included watercress (*Nasturtium officinale*), dropwort (*Oenanthe crocata*) and brooklime (*Veronica beccabunga*).

Plate 5. Section D showing discharge pipe from right bank.

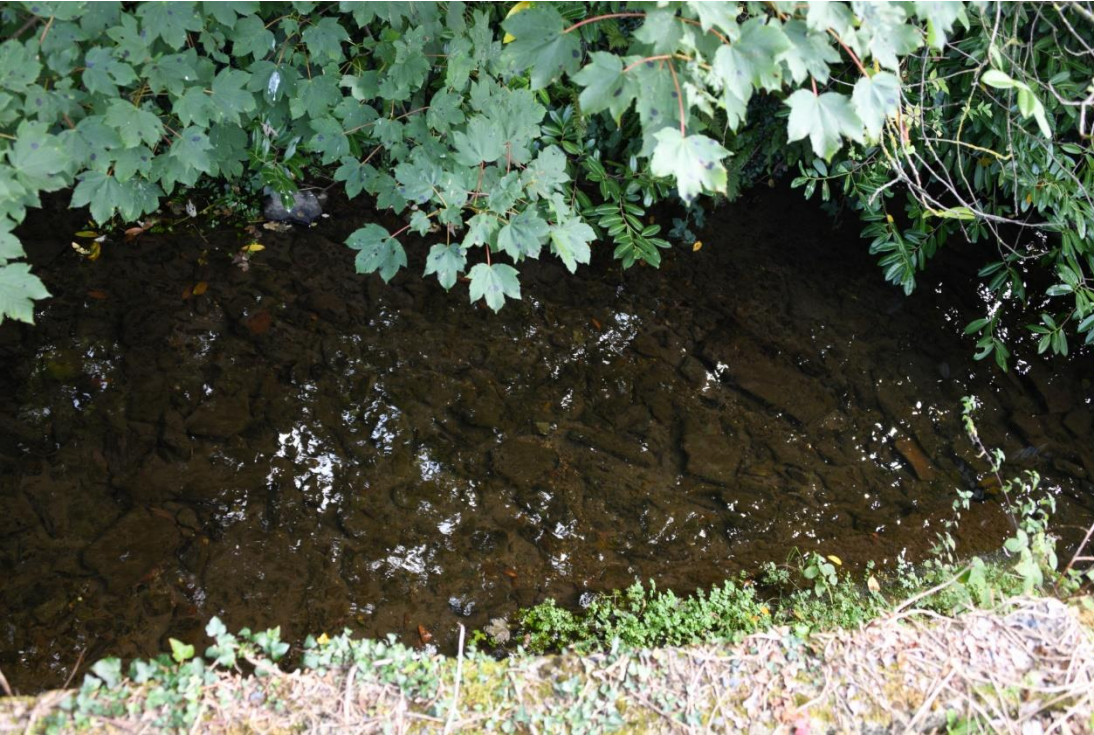
Plate 7. Section E.

Downstream of Ballyhale just prior to and where the watercourse enters the SAC (Figure 3) is a very good example of salmonid habitat. Just downstream of the bridge juvenile salmonids were noted in this section and although they were not observed it, would be expected that freshwater crayfish would be present in this area, given the history of the species downstream. Otter spraints were also noted in this area. The area is slightly tunnelled but the depth of the water and gravel features would indicate that this is an important area for local biodiversity and would be sensitive to impact from works. The pool located in this area is possibly caused by scouring following the water exiting the culvert, with increased velocities. However, it does indicate that should salmonid enhancement measures and design elements be put in place on this stream a significant improvement in instream biodiversity would be seen. It is therefore recommended that NPWS and IFI are consulted throughout the design process.

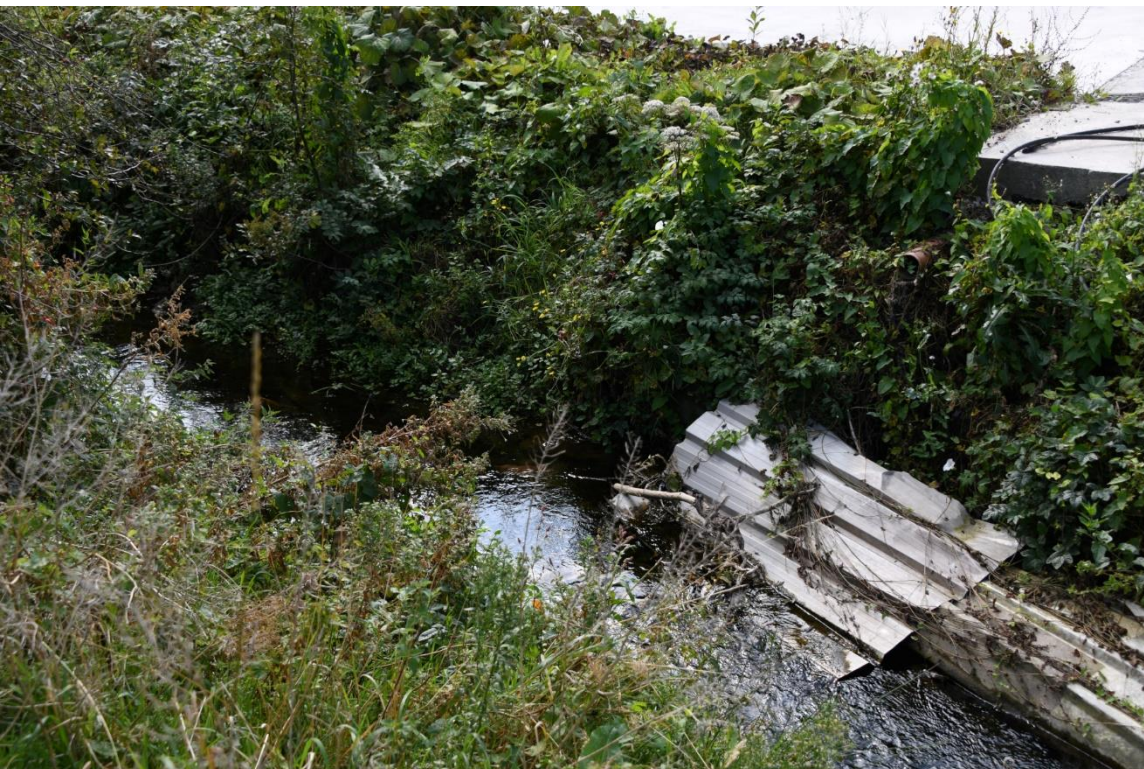
Downstream of Section E the watercourse travels very tightly beside a series of industrial units with several what appear to be surface water discharges. In this area the stream is primarily heavily tunnelled which provides a biodiversity corridor for species such as otter but also results in poor in stream vegetation and cover for biodiversity. Areas of the stream in this section are slightly silted. However, much of the bed of the stream consists of exposed gravels. No instream macrofauna was observed in this section. However, based on the previous records Freshwater crayfish and salmonids would be expected in this area. Of note within this section is the Ballyhale-Knocktopher Urban Wastewater Treatment plant which carried out secondary treatment. Overall compliance in this WWTP is a “pass”.

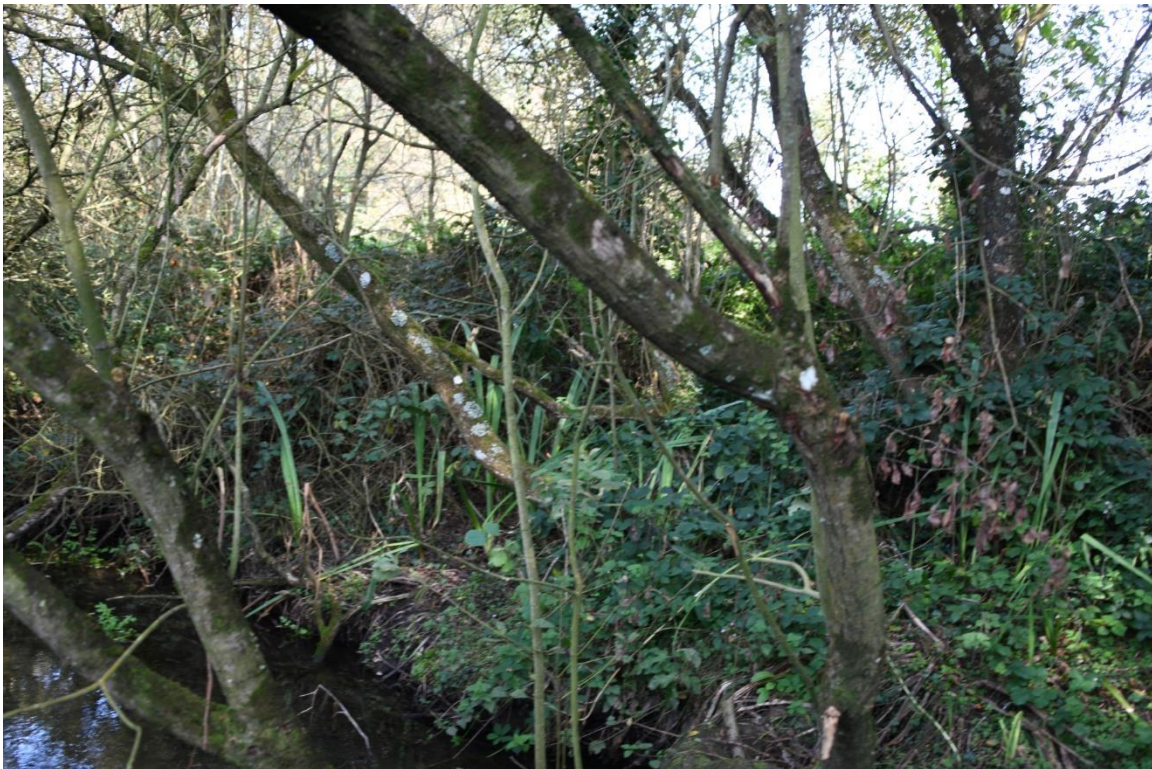
As can be seen from Figure 1 two route options terminate on the River Arrigle. This is within the River Barrow and River Nore SAC. This section of the river would be seen as being ecologically important from a biodiversity perspective. An area of wet woodland (WN6) is seen within this area and corresponds to a priority type (alluvial forests with *Alnus glutinosa* (alder) and ash, *Fraxinus excelsior* (91E0)) listed in the Habitats Directive. In addition, the Annex Habitat [3260] Floating River Vegetation was observed on site. The habitat quality and records indicate that the site would support, Atlantic salmon (*Salmo salar*), brook lamprey (*Lampetra planeri*), river lamprey (*Lampetra fluviatilis*) and sea lamprey (*Petromyzon marinus*) requirements for spawning, nursery and adult habitat. In addition, the watercourse supports otter (*Lutra lutra*) and crayfish (*Austropotamobius pallipes*) signs of which were observed on site.

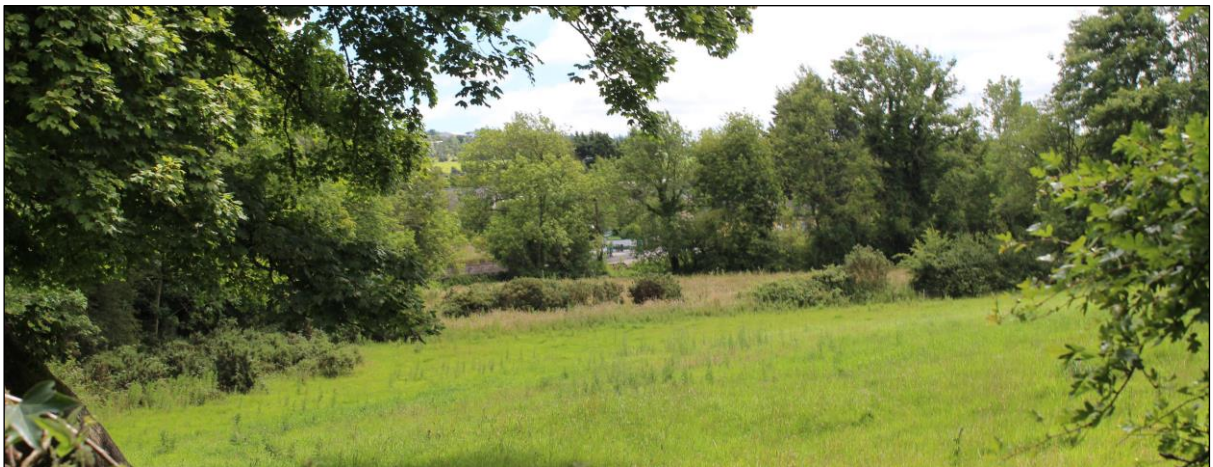
Plate 8-1: Floodplain of stream with mature tree lines, south of Ballyhale

Plate 8-1 below shows the floodplain of the stream just south of the village.

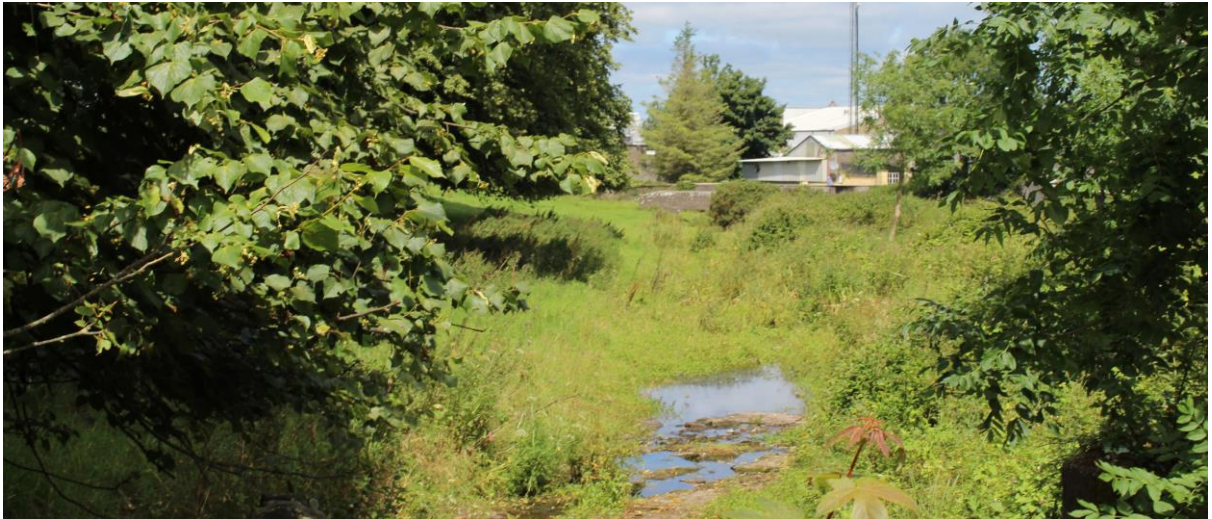
Plate 8-2: Ballyhale Stream continues through field west of Church

The stream crosses under the road south of the church, and flows along to the west of the church, as shown in Plate 8-2 below. The flow at the time of the site visit was shallow.

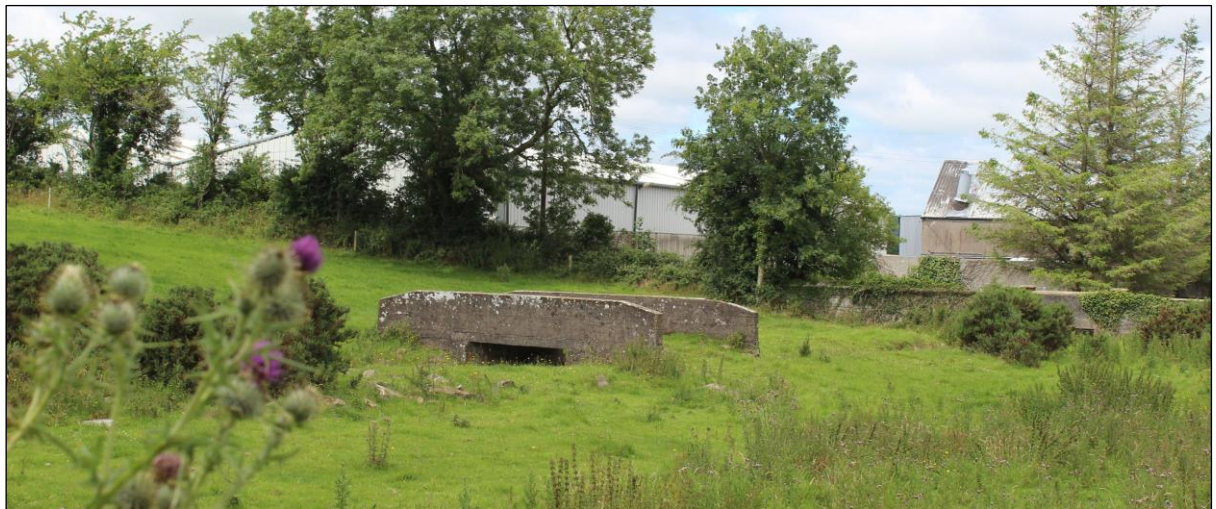
Plate 8-3: Stream continues through open field towards business park

The stream then travels through the open field, west of the church, with mature trees evident in the area. The stream was not prominent at the time of the site visit, but its route is indicated by a bridge as shown in Plate 8-3 below. It continues towards the Arrigle business park, seen in the background of Plate 8-3 below.

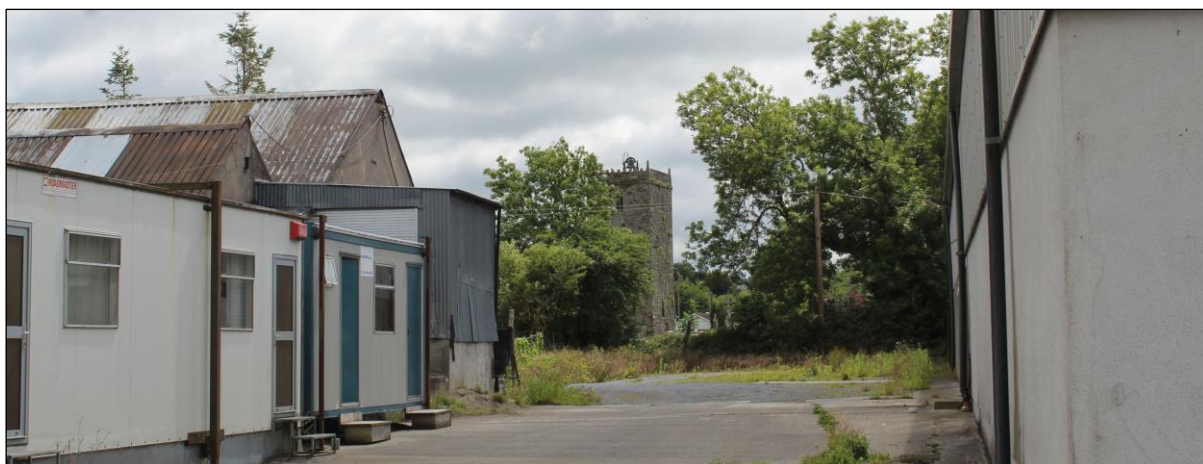
Plate 8-5: Stream is culverted under Arrigle business park

The stream continues through the Arrigle Business Park, where it is culverted, and appears along the main street adjacent to the road, where it is very overgrown in some areas. Plate 8.5 shows the dense vegetation along the river in this section:

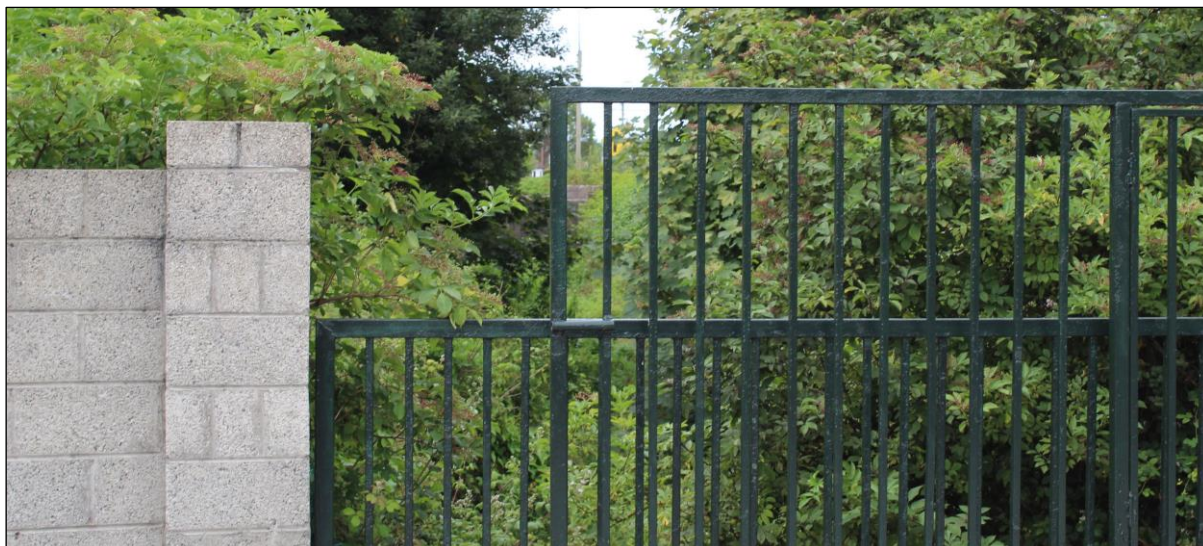
Plate 8-6: Overgrown stream along Main Street

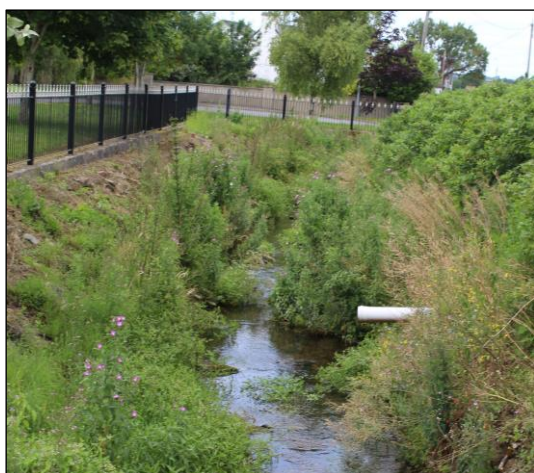
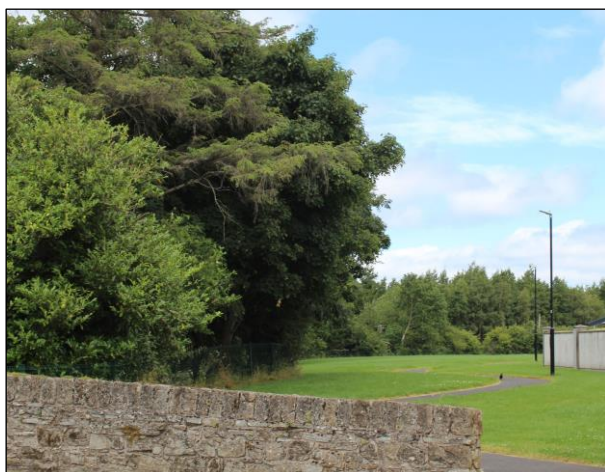
Plate 8-7: Stream adjacent to Hazelbrook development *Plate 8-8: Ballyhale Bridge and adjacent trees*

The stream continues to flow adjacent to the Hazelbrook residential development, as shown in Plate 8-7, where it is more visible but still overgrown. It then runs under the main road at Ballyhale Bridge, where it meets the River Arrigle, and flows between an

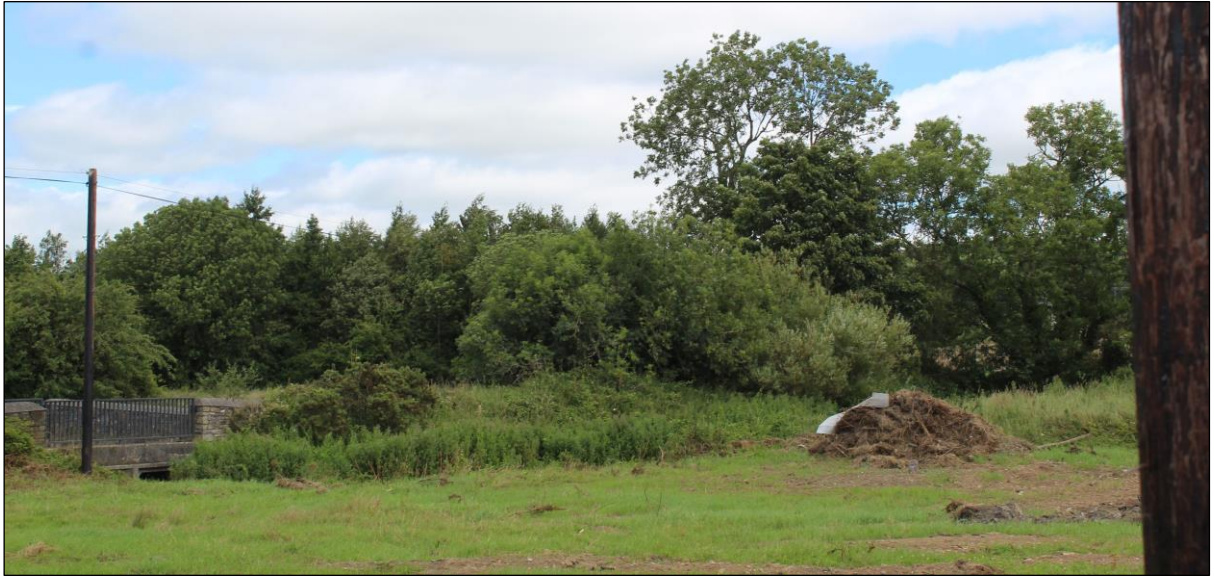
Plate 8-9: River flows through SAC at northern end of the village

area of open space, lined by mature trees, an area of SAC (which appeared recently cleared at time of site visit) to the north. This is shown in Plate 8-9 below.

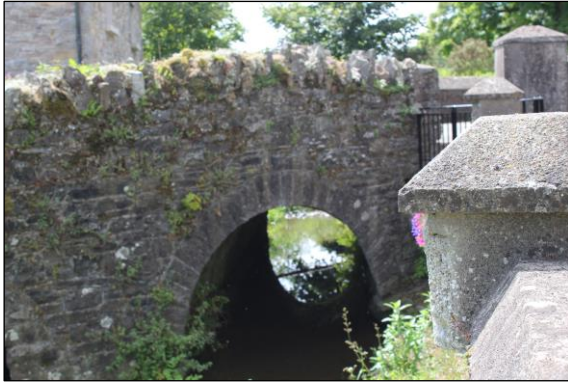
Plate 8-14: Stone arched bridge
