Ballyhale Flood Relief Scheme, Ballyhale, Co. Kilkenny

Environmental Constraints Report

Job Title: Ballyhale Flood Relief Scheme

Report Ref: 200055-DBFL-XX-XX-RP-0002

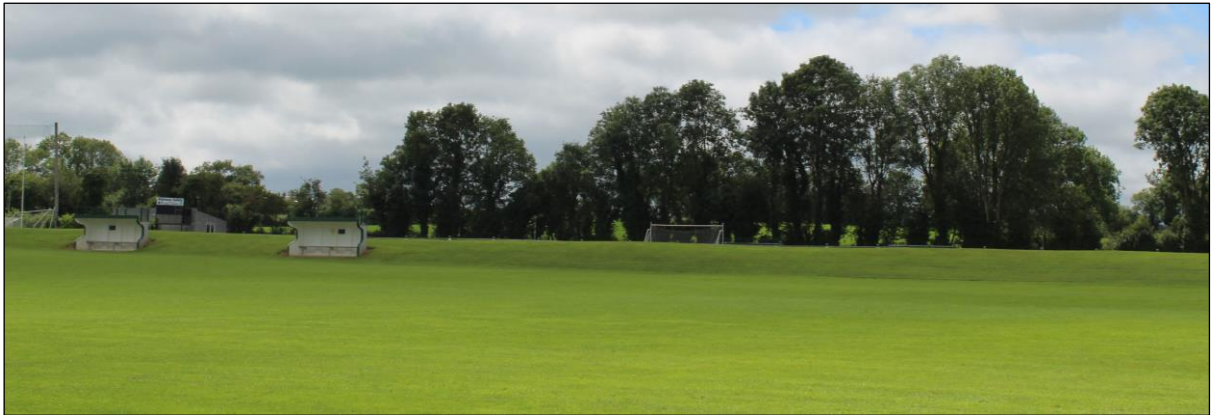
Plate 8-18: Mature tree line west of Ballyhale Shamrocks GAA pitch

Pairc na Seamróga consists of a large pitch (with a training pitch) surrounded by a walking track with several small buildings. The boundary contains some mature trees especially to the west and south, as shown below:

- The mature trees which are a conspicuous feature of several areas. There are also noted on the Urban Design Map in the LAP, and include the tree lines to the south of the Church (in the fields), as well as those in the vicinity of the church itself, especially those to the west along the stream corridor and surrounding the manor house to the west. Other mature tree lines are located to the west of the GAA pitch, and south of the GAA pitch//Business park.

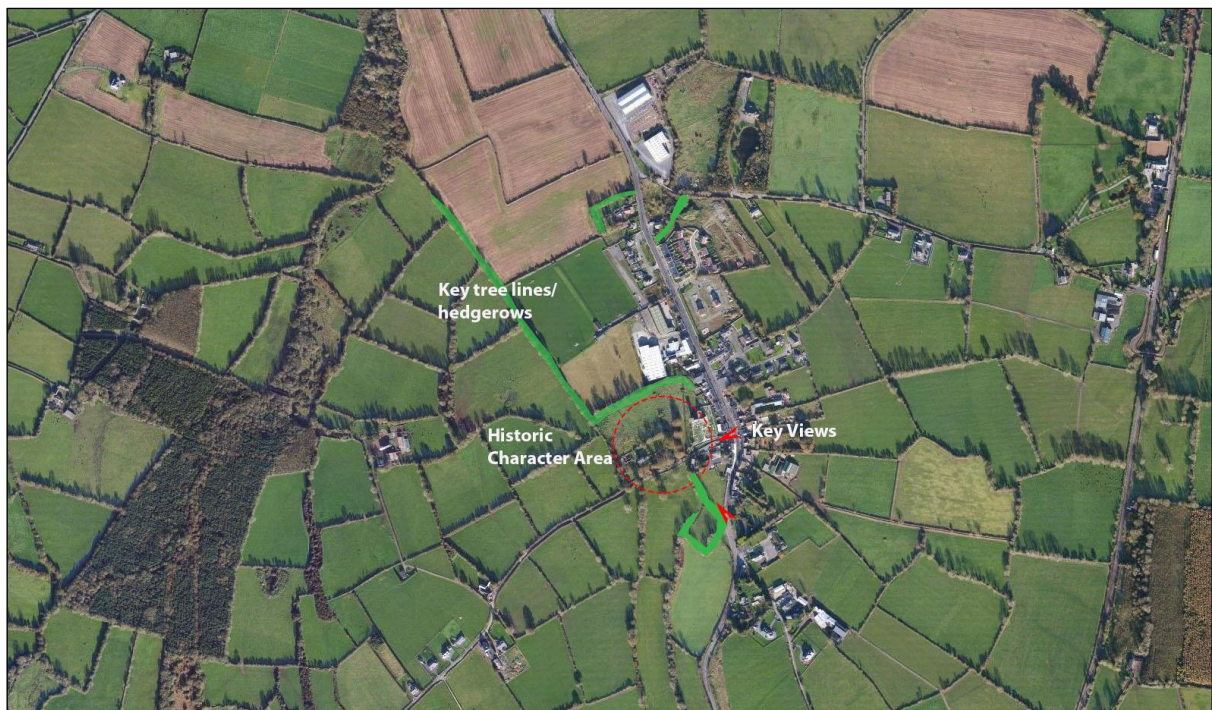
Figure 8-4: Key landscape features and views

The key landscape elements are indicated on Figure 8-4.

tower) is visible among mature trees. The visual amenity in the vicinity of the church and area to the south and west, is considered high, and there is a key view from the main street towards the stream, bridge, church and trees. These are indicated on Figure 4 above.

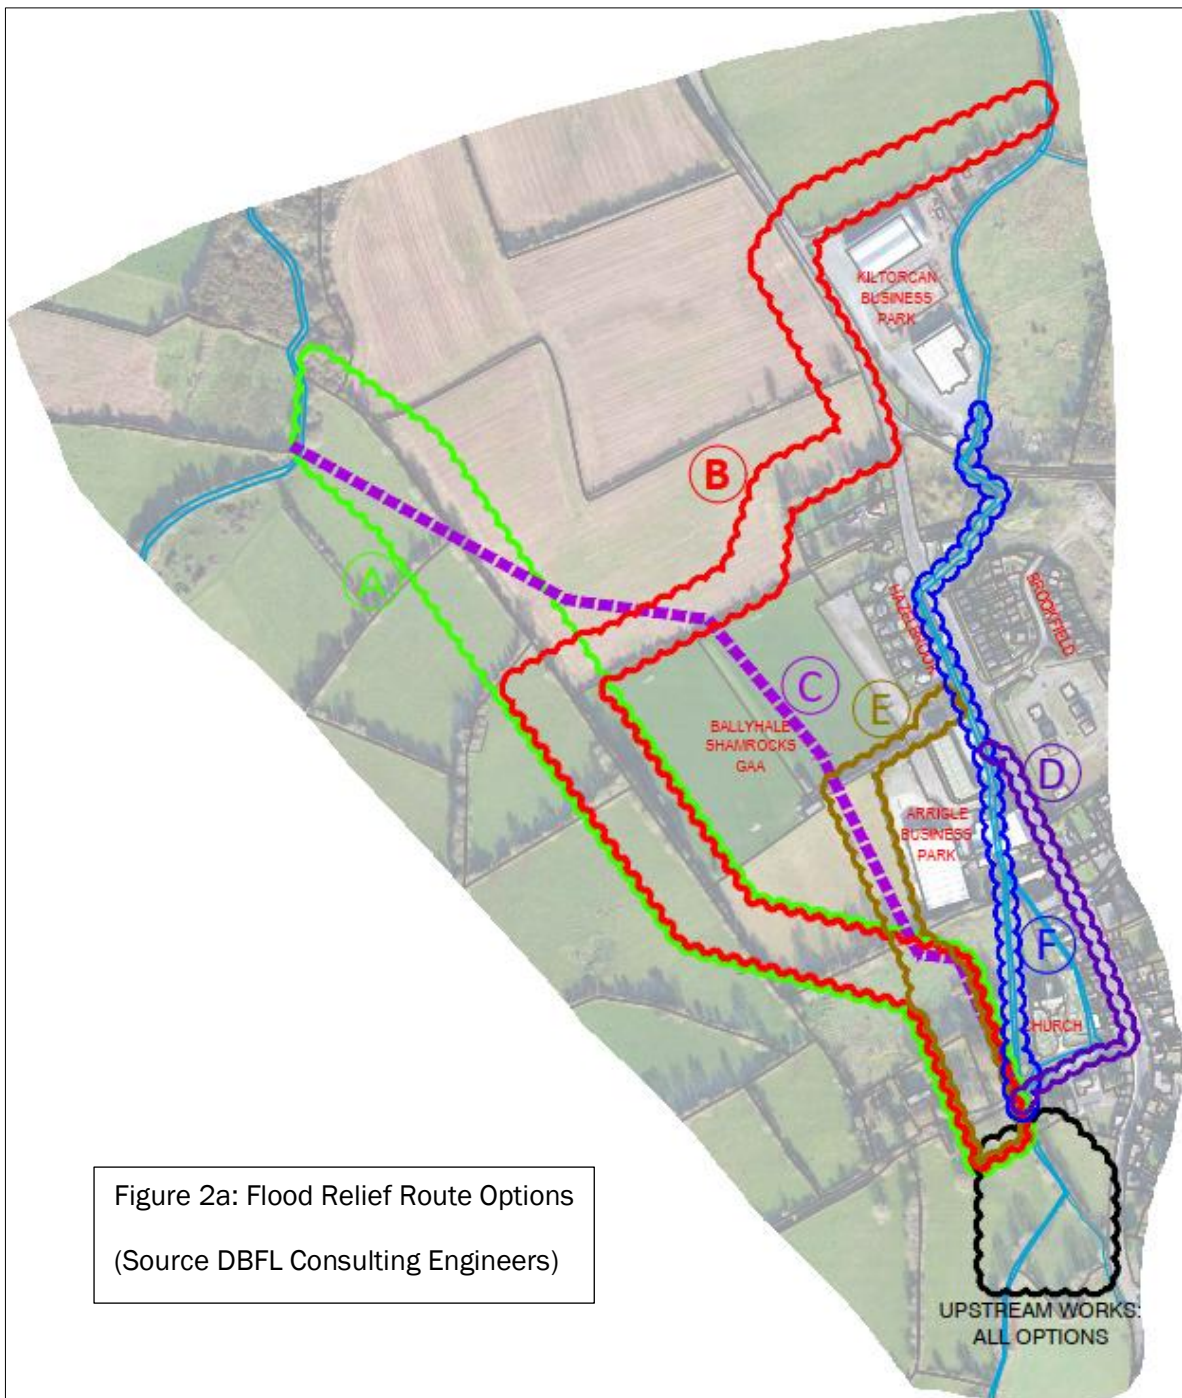
Figure 2a: Flood Relief Route Options
(Source DBFL Consulting Engineers)

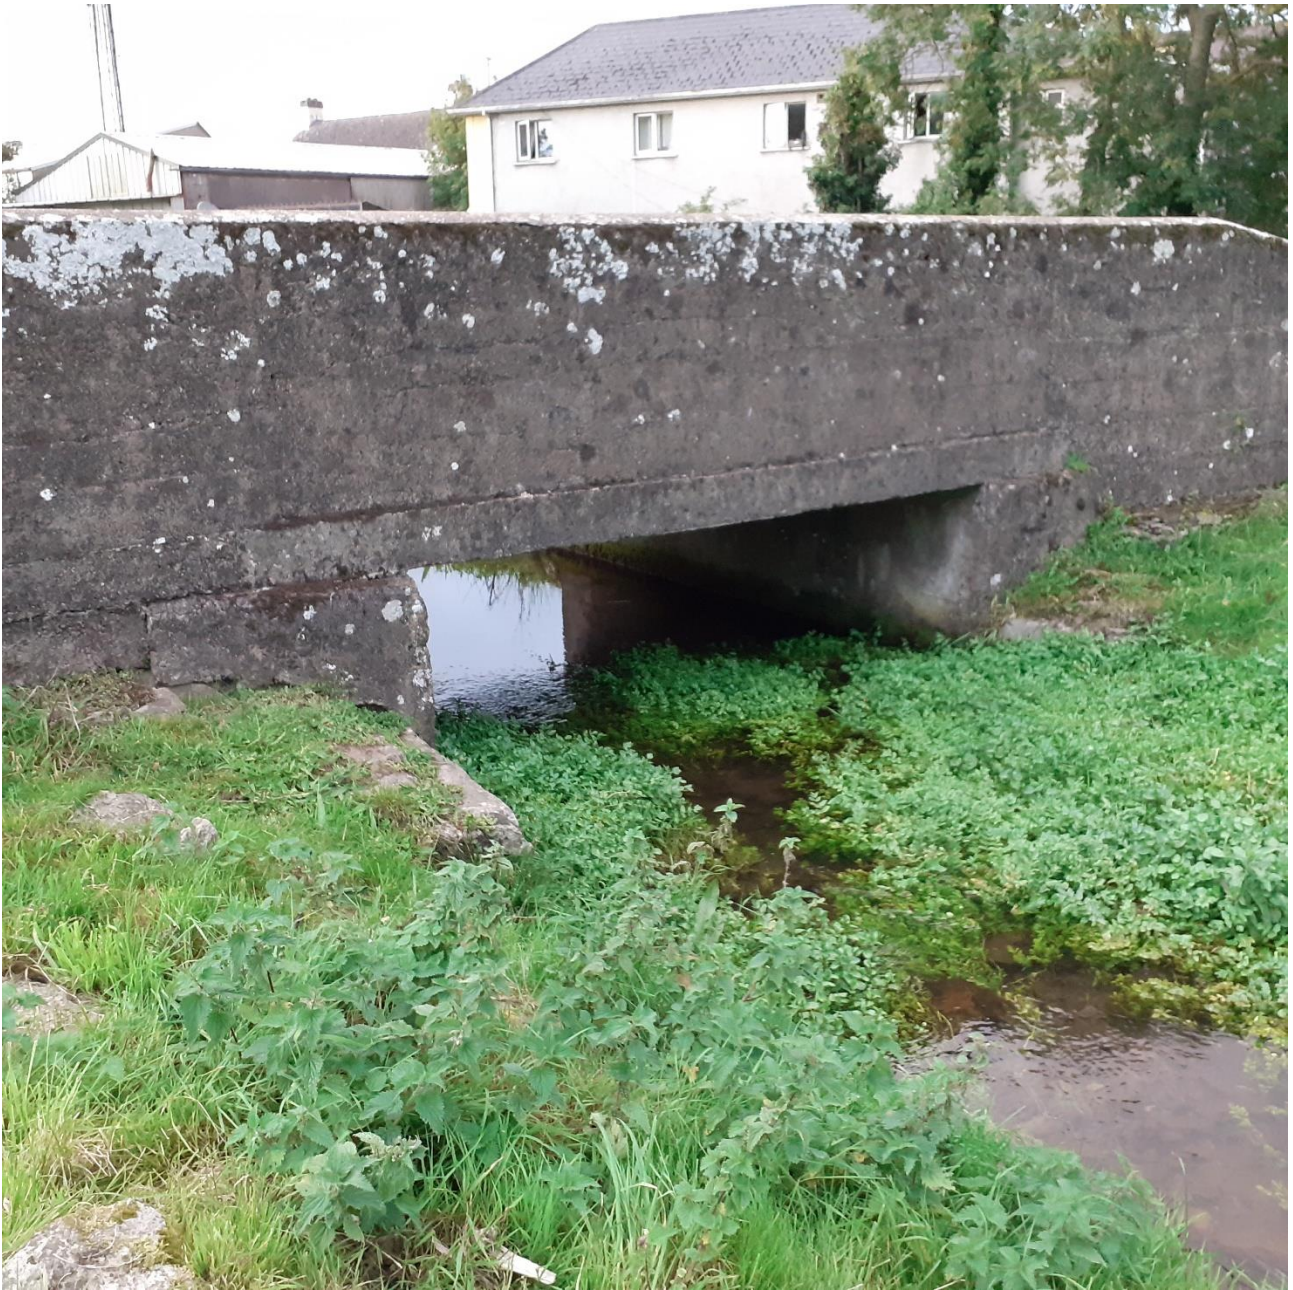
Plate 1: Bridge 10, Ballyhale, Co. Kilkenny.

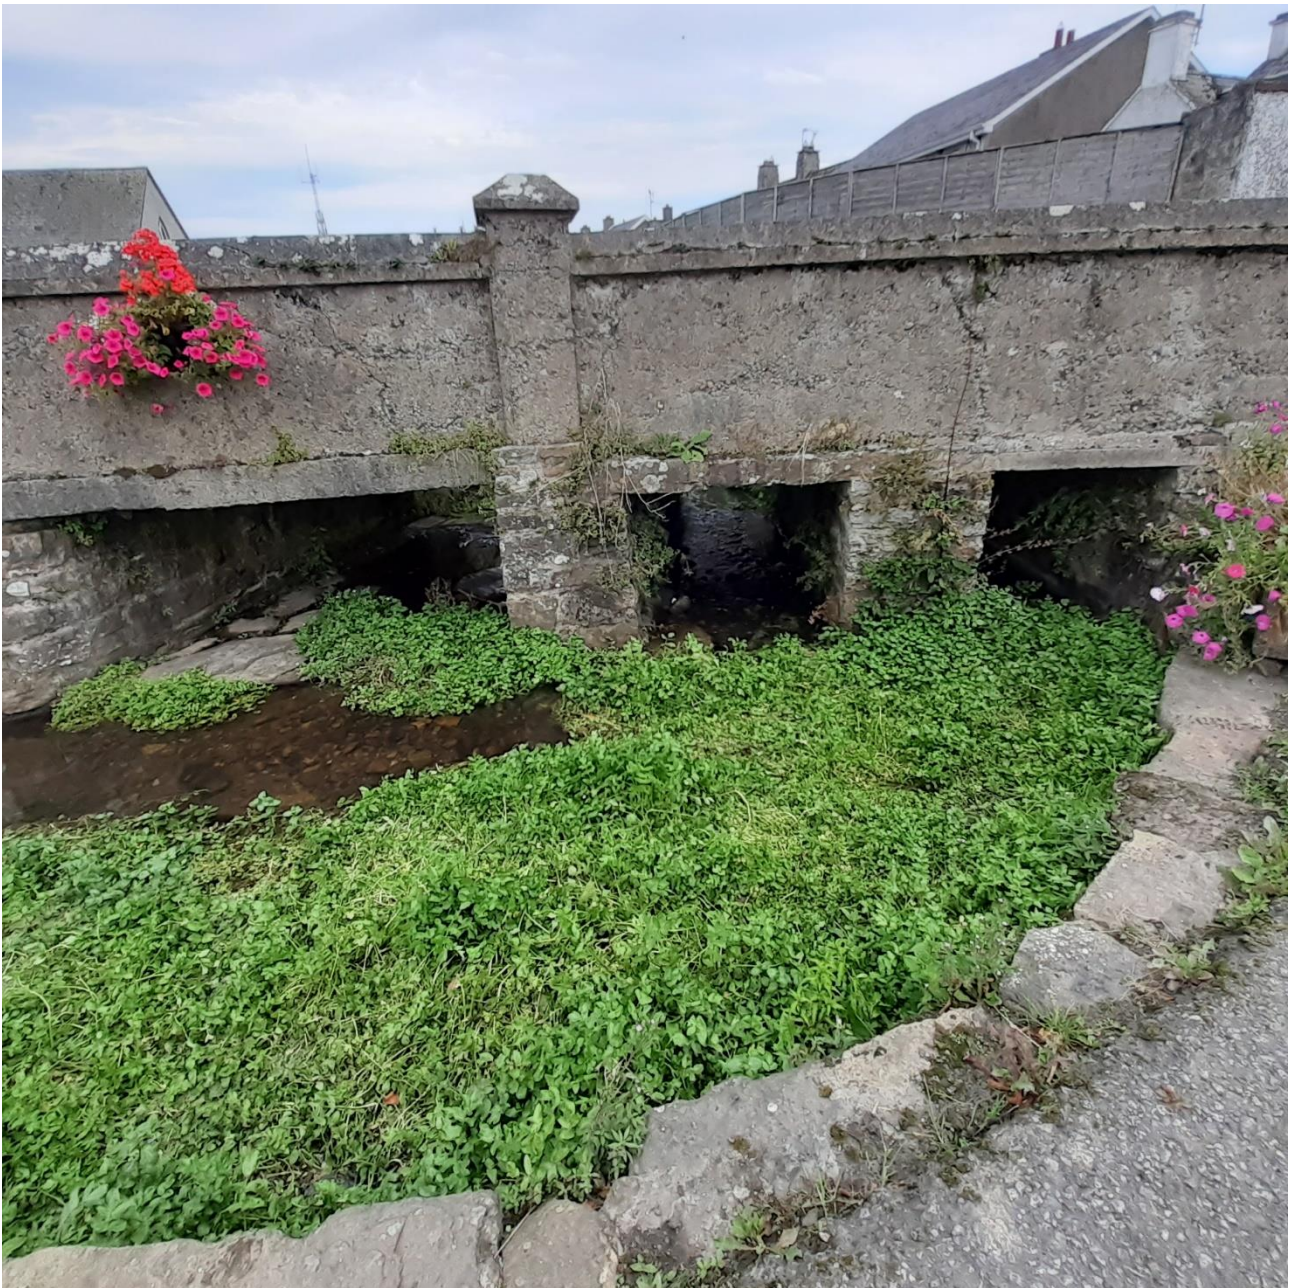
Plate 2: Bridge 8, Ballyhale, Co. Kilkenny.

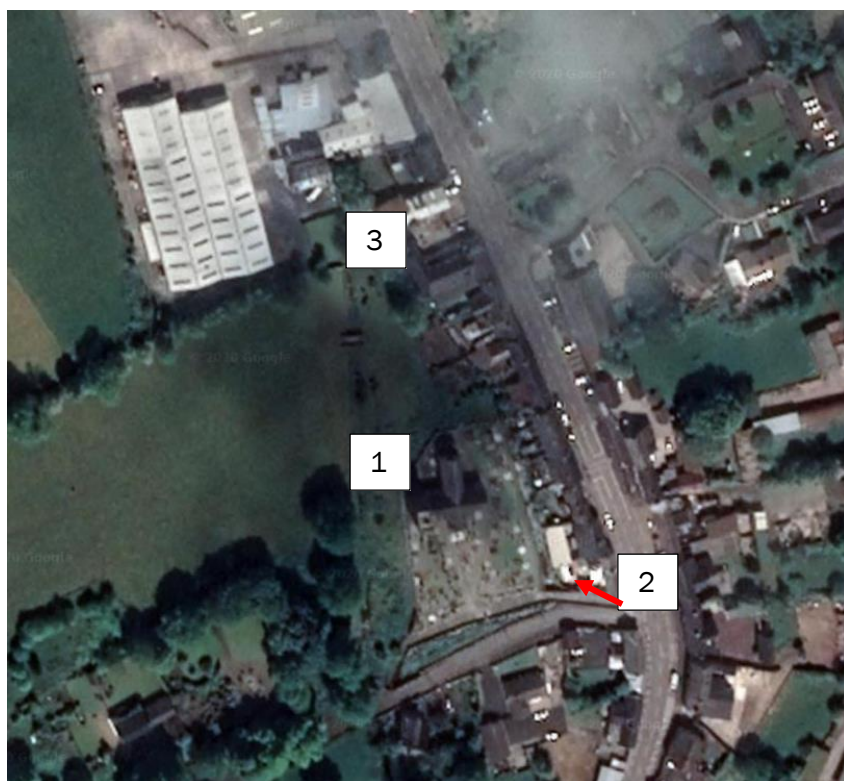
Figure 4a: Roost Surveys.

The following figure (Figure 4a) and Table 10 summarises the results of the bat detector surveys completed in relation to buildings located within the survey area.

Building Code	Roost Type & Location	Bat Species (No. of bats)	Access Points	Vegetation / Lighting arrangement
Church (1) Plate 5	None	None	Not applicable	Yes - present
Private residence (2)	Roof space	Soprano pipistrelle (satellite roost)	Facia board/soffit	Yes - present
Shed (Business Park) (3) Plate 6	None	None	Not applicable	Yes - present

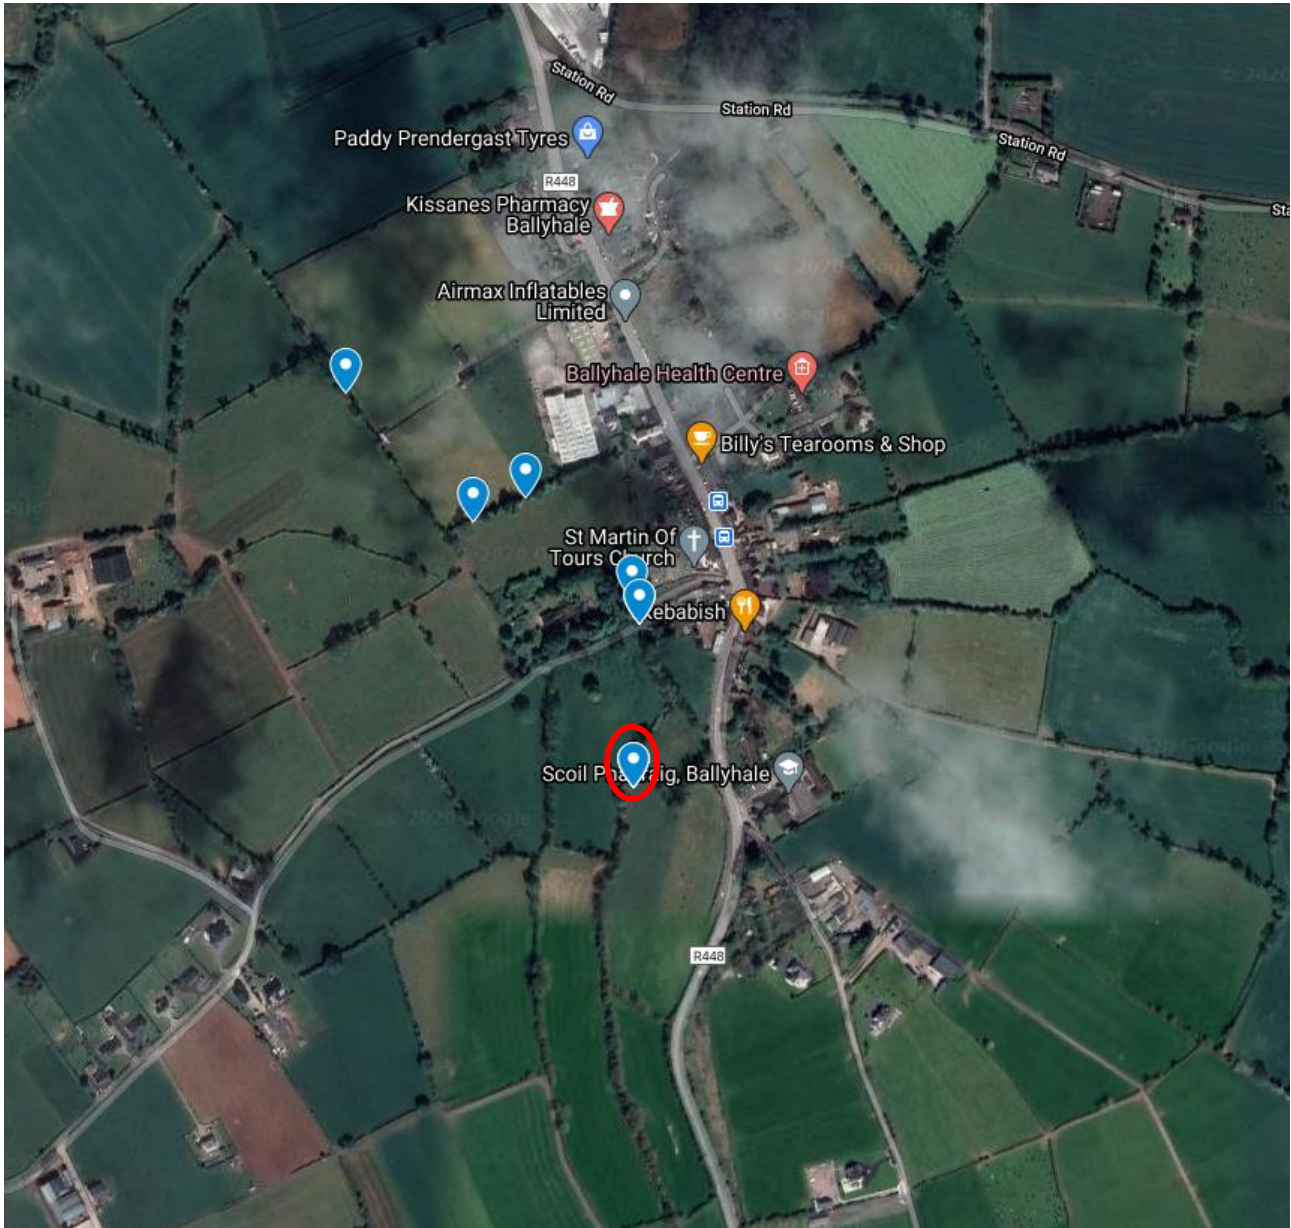
Figure 4e: *Myotis* species bat encounters (Natterer's bat & Daubenton's bat) within survey area (Blue Icons). Red Circle – location of static recording unit and area of high Natterer's bats encounters.

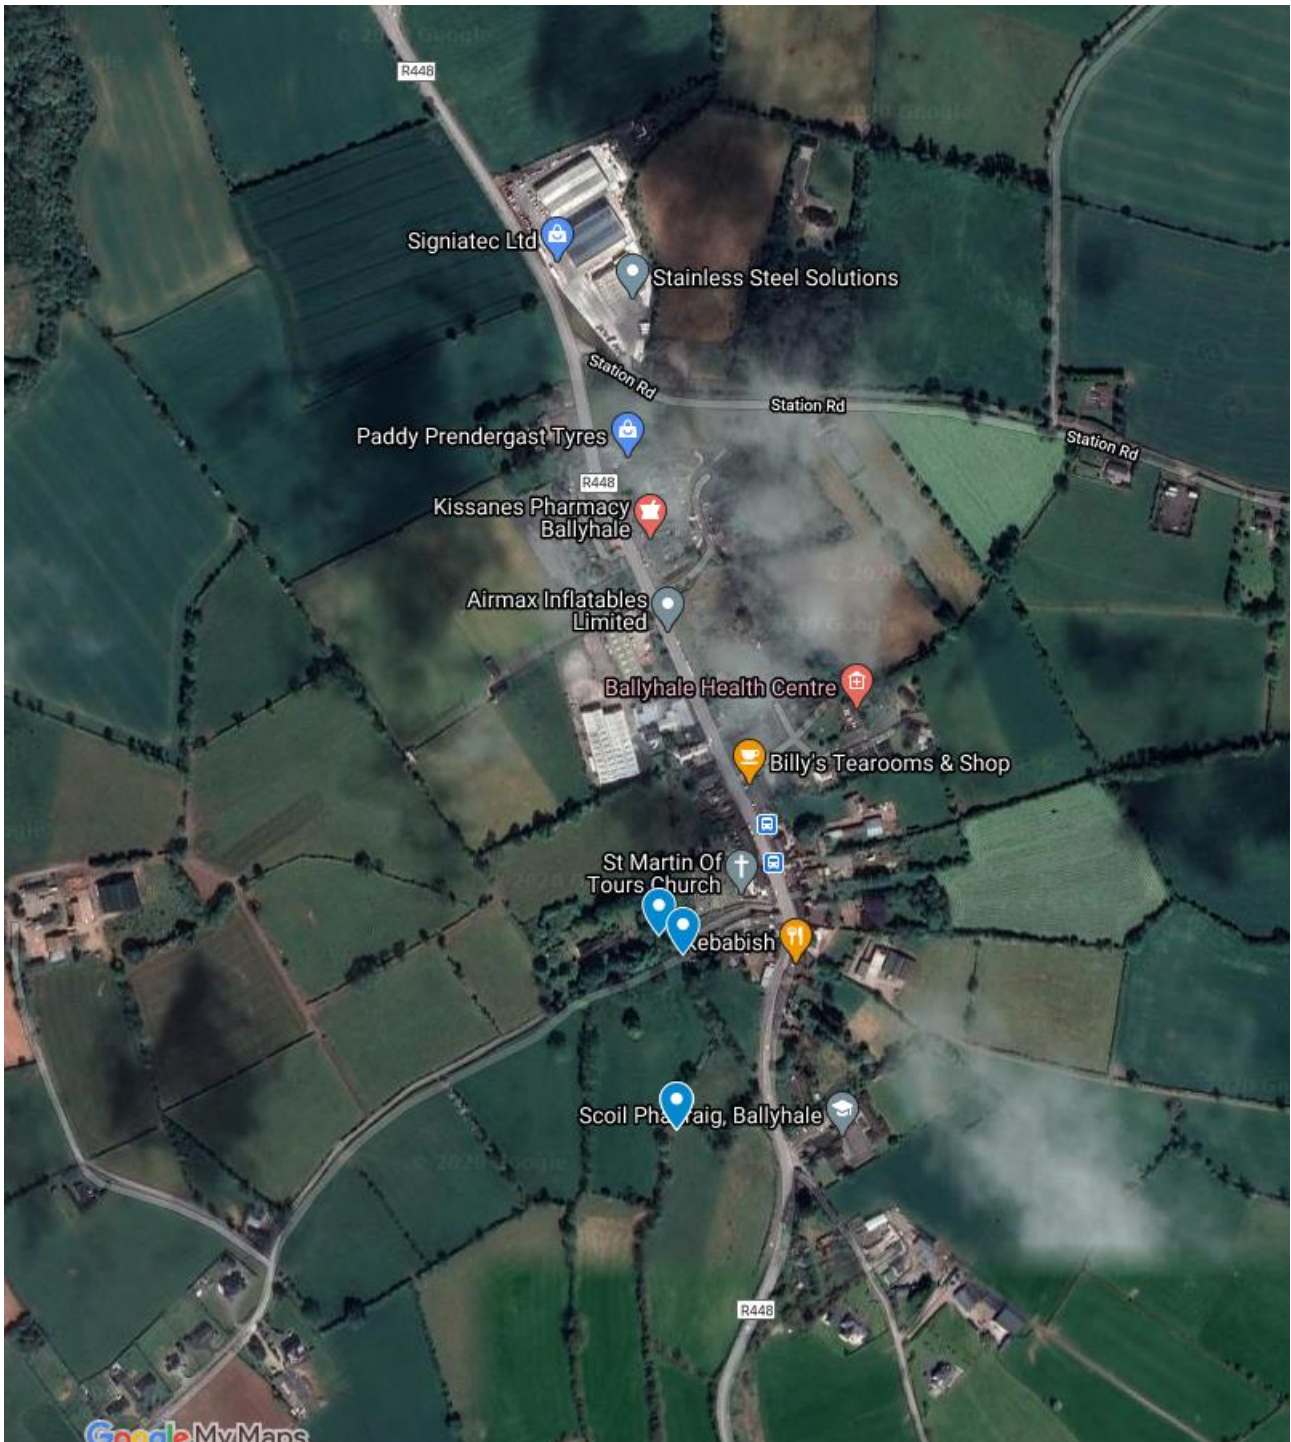
Figure 4f: Brown long-eared bat encounters within survey area (Blue Icons).

Brown long-eared bats were recorded in three areas and these areas were associated with dense treelines and also away from street lighting. This bat species is also light sensitive.

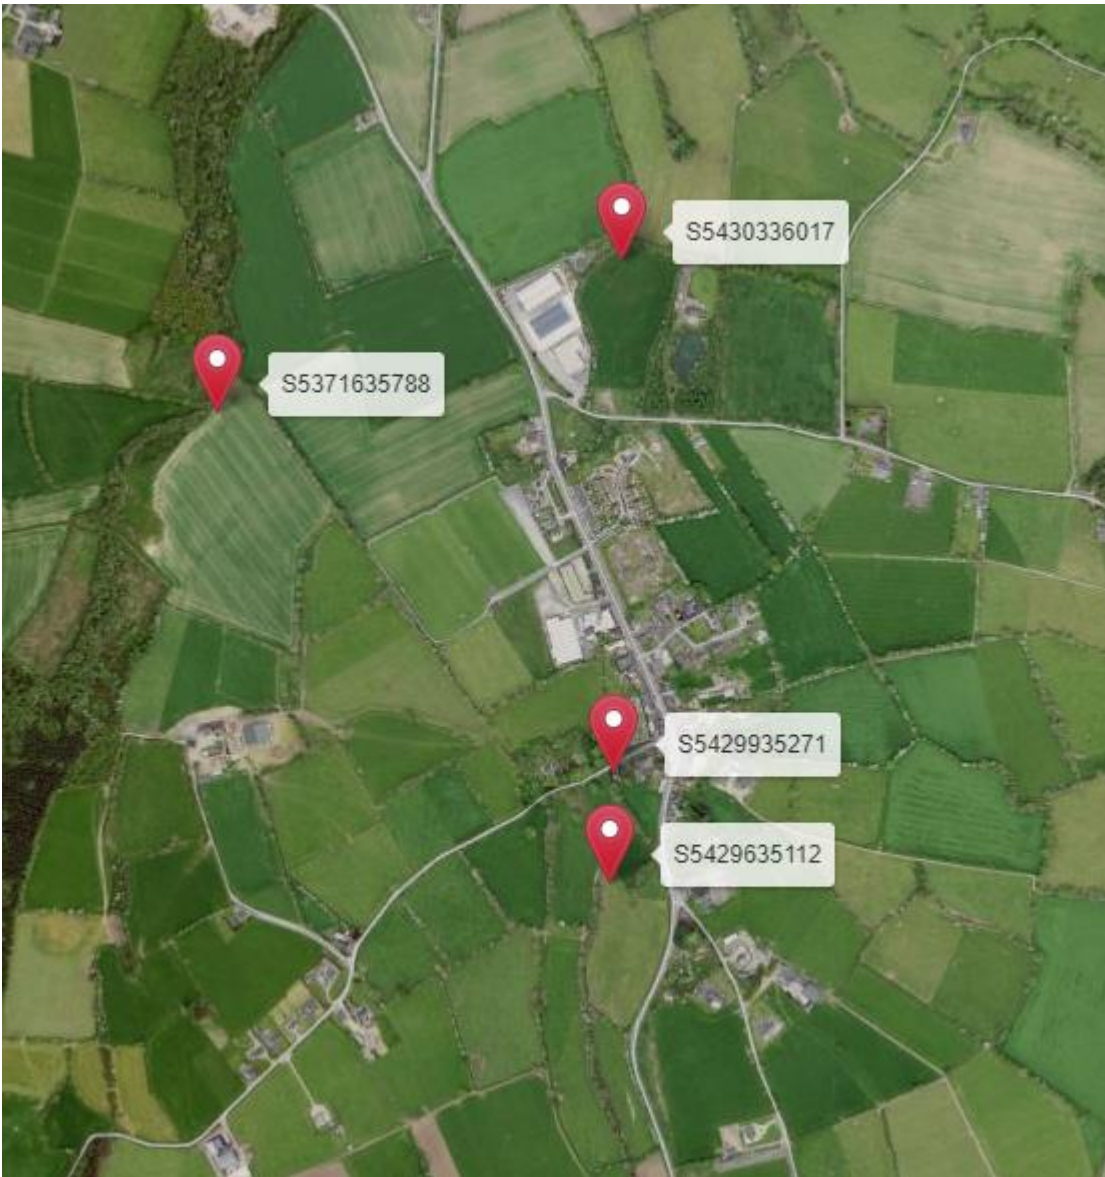
Figure 5: Location to static units during static surveillance.
